# Haldimand County Lake Erie Hazard Mapping and Risk Assessment

Technical Report

March 19, 2020 | 12969.101.R2.Rev3

W.F. Baird & Associates Coastal Engineers Ltd.  
and  
Terraprobe Inc.

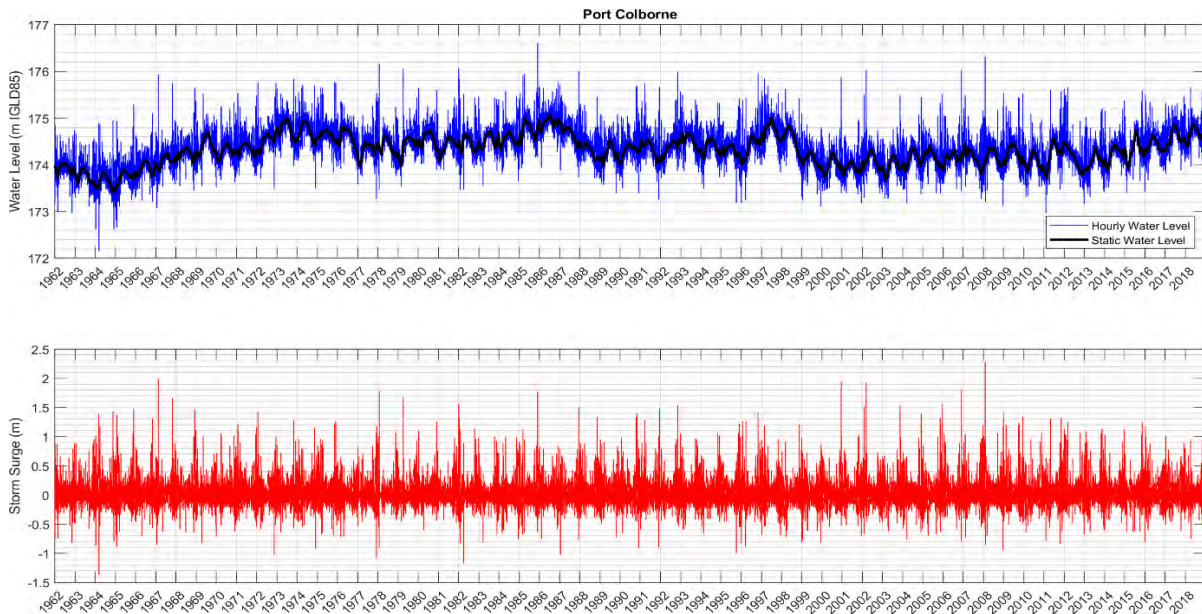
**Figure 6.2: Hourly and static water level and calculated surge at Port Colborne 1962 to 2018**

Baird updated the storm surge analysis using the 57 years of hourly water level data (1962-2018). In the analysis, static water levels were calculated using a Gaussian-weighted 30-day moving average filter to eliminate the stairstep effect between months. Surge was calculated by subtracting the hourly water level measurements from the “smoothed” static water level. Hourly water levels, calculated static levels, and calculated surges for Port Colborne are shown in Figure 6.2.

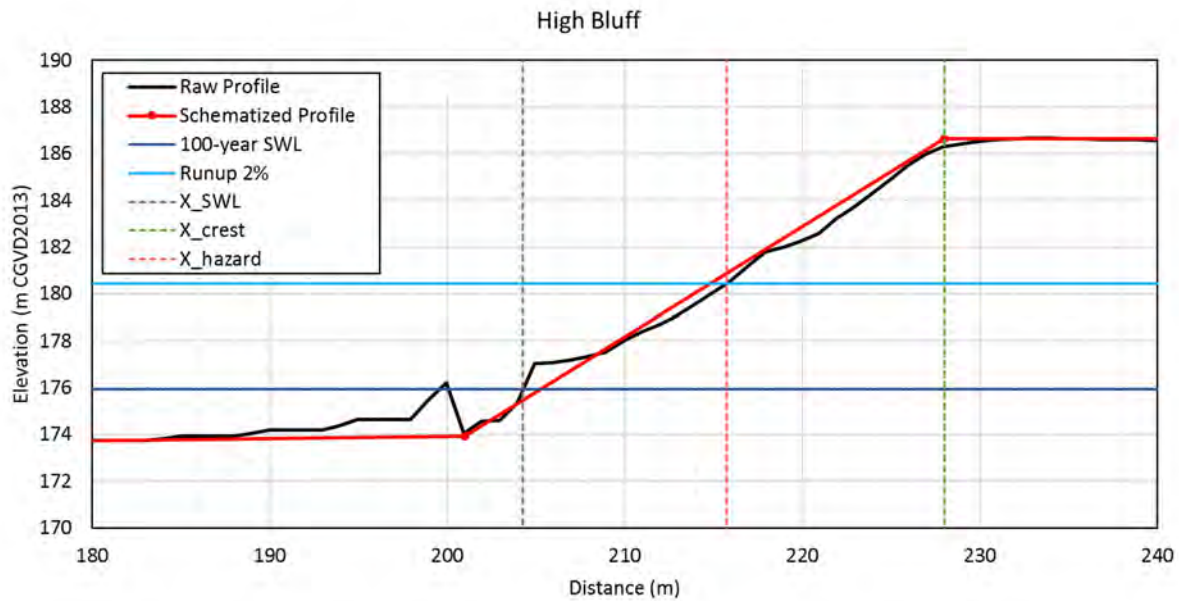
**Figure 6.6: Example of wave uprush on a high bluff**

An example of the wave runup elevation and corresponding horizontal runup distance on a high bluff is shown in Figure 6.6. In this example, the wave runup is 4.5 m above the 100-year flood level, and the corresponding

horizontal runup distance is 11 m. In this figure, the “spike” at x=200 m is an artifact of the merging of the different LiDAR datasets at the shoreline and, as such, the “spike” is ignored.

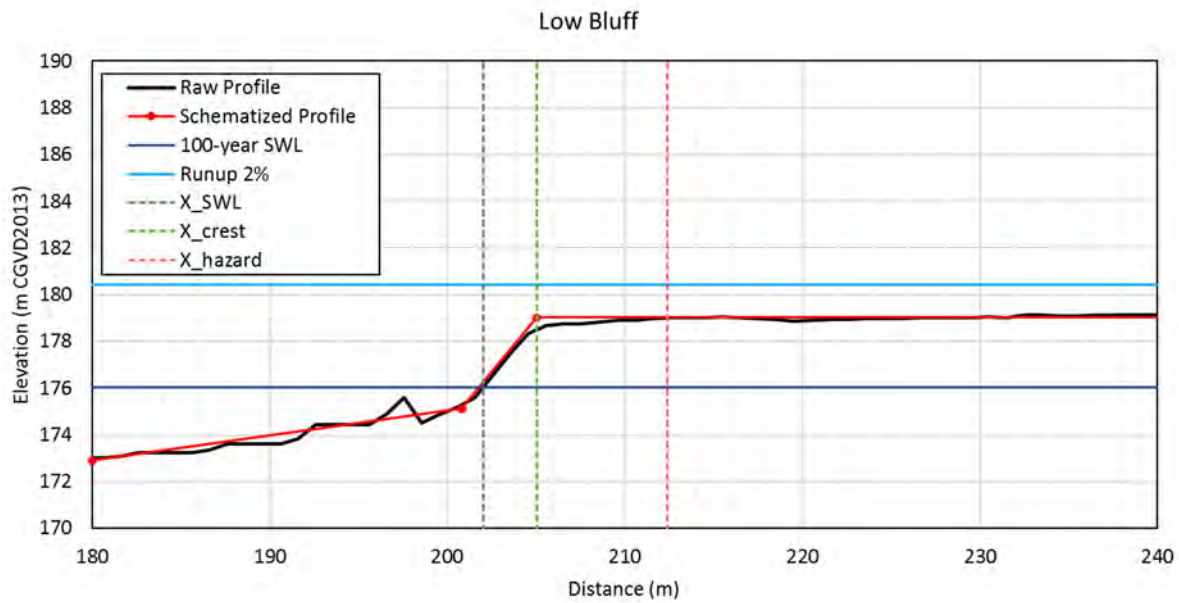
**Figure 6.7: Example of wave uprush on a low bluff**

An example of wave runup on a low bluff is shown in Figure 6.7. In this example, the wave runup is 4.6 m above the 100-year flood level, which exceeds the height of the bluff by 1.4 m.

In the example shown in Figure 6.7, the horizontal extent of wave uprush is 10 m (3 m horizontally on the slope and 7 m from the slope crest to the distance  $L_s$ ).

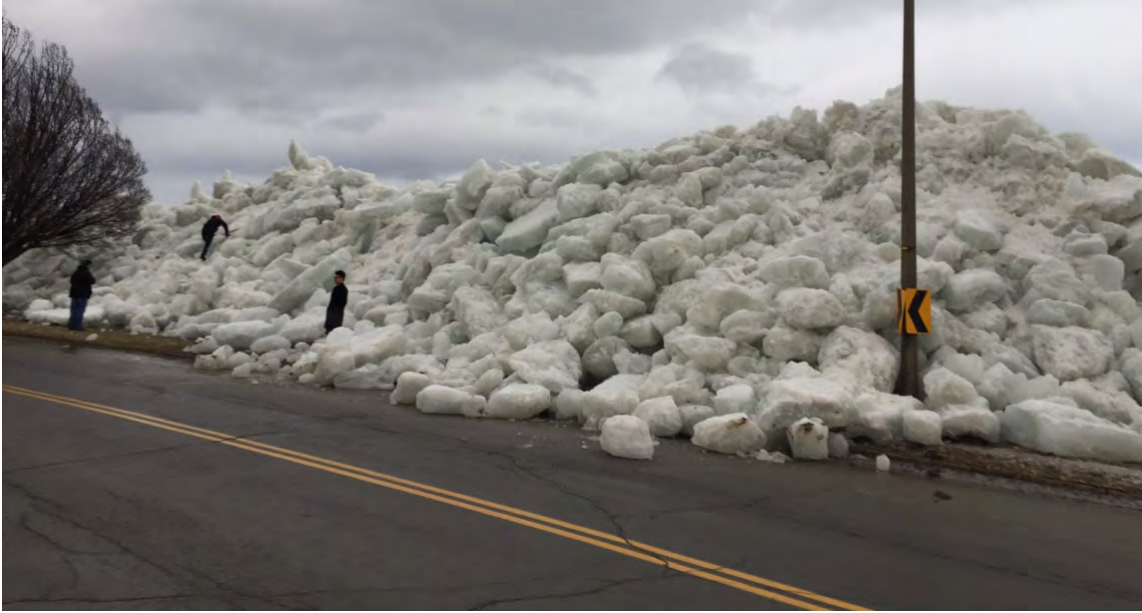
**Figure 6.8: Ice pile-up along Lake Erie shoreline in Fort Erie, Ontario during Feb 25, 2019 (Mazza, 2019)**

A photograph of the February 25, 2019 ice pile-up event at Fort Erie, Ontario (east of Haldimand County) is shown in Figure 6.8. No historical ice pile-up events of this magnitude were identified by the project team for Haldimand County.

The risk factors were assessed using the reach profiles developed for the wave uprush estimates. The 100-year flood level was used for the freeboard risk factor estimates and is representative of a high-water condition that could occur during an ice pile-up event. Three metres was selected as a reasonable bluff height that would contain/limit the landward progression of an ice pile-up event (e.g. see Figure 6.8).

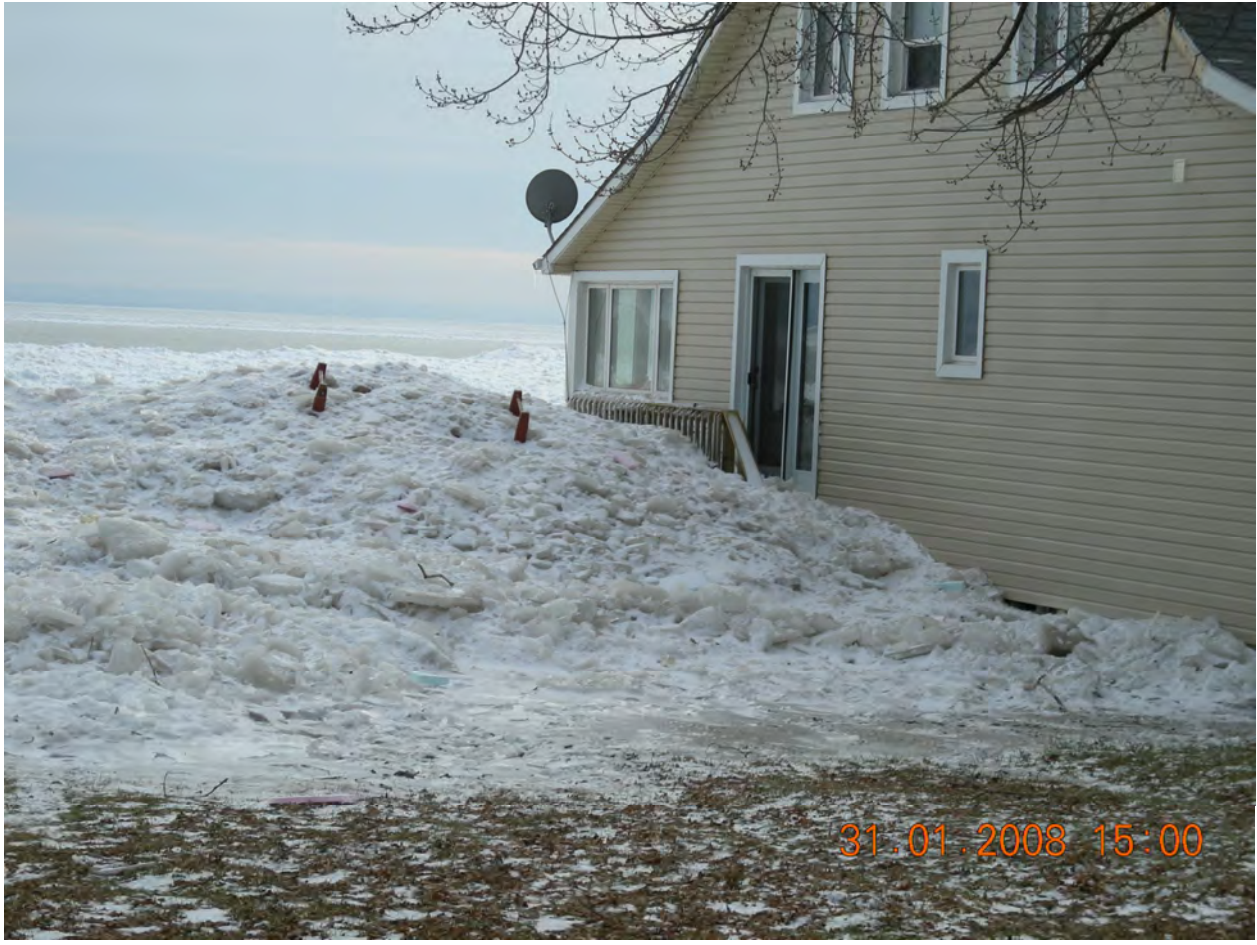
**Figure 6.9: January 31, 2008 ice pile-up event in Niagara County (from NPCA)**

A literature review was conducted to understand the historical risk of ice damage along the Haldimand County shoreline, and to obtain information or reports of past occurrences. From the literature review, and consultation with representatives of GRCA, NPCA, LPRCA and Haldimand County, it appears Haldimand County has historically had minimal impact due to ice pile-up. Ice piling is more common along the Niagara County shore of Lake Erie, where ice pile-up events have occurred in 2014, 2018, and 2019 (see Figure 6.9).

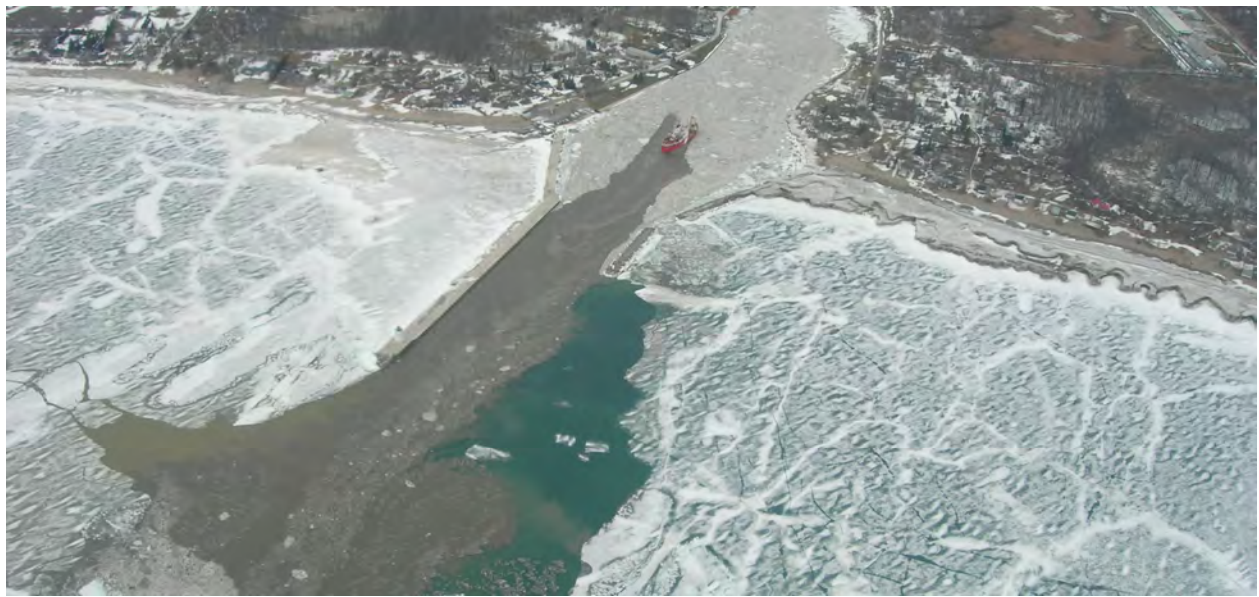
**Figure 6.11: Canadian Coast Guard ice breaking operations in the Grand River, February 2009 (GRCA)**

In Haldimand County, ice jams near the mouth of the Grand River are the primary ice and flooding concern. In January 2008, the combination of storm surge and wind, pushed a large amount of ice upstream into the Grand River, resulting in flooding near Dunnville. The Canadian Coast Guard often carries out ice breaking operations at the river mouth in the late winter to reduce the potential for upstream flooding (see Figure 6.11).

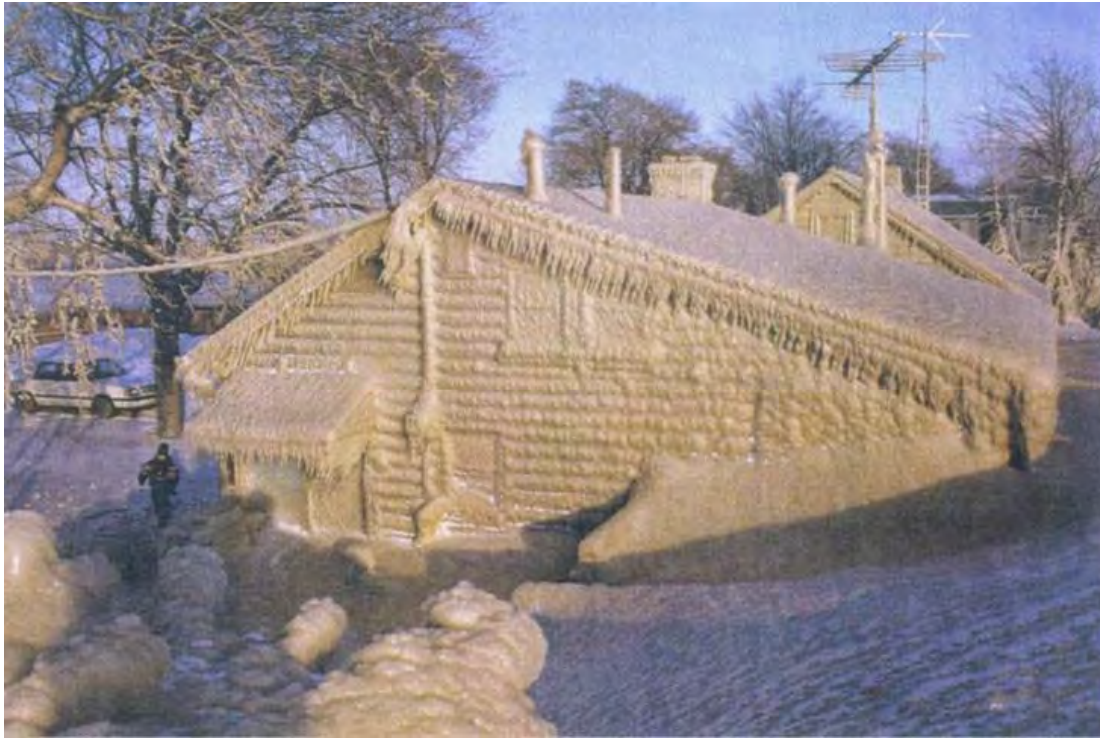
**Figure 6.12: Example of Lake Erie ice spray on Erie Shore Drive (from LTVCA, date unknown)**

In terms of less severe ice effects along the Haldimand County shoreline, anecdotal reports were obtained from the GRCA and various residents. From the information obtained, it is evident that ice spray can occur during winter months when the lake is not completely frozen, or ice has been broken up by wave action. This combined with winds, results in the spray of waves icing structures along the shoreline. Specifically, this was noted to have occurred in December 1985 and February 2019 but may occur more frequently.

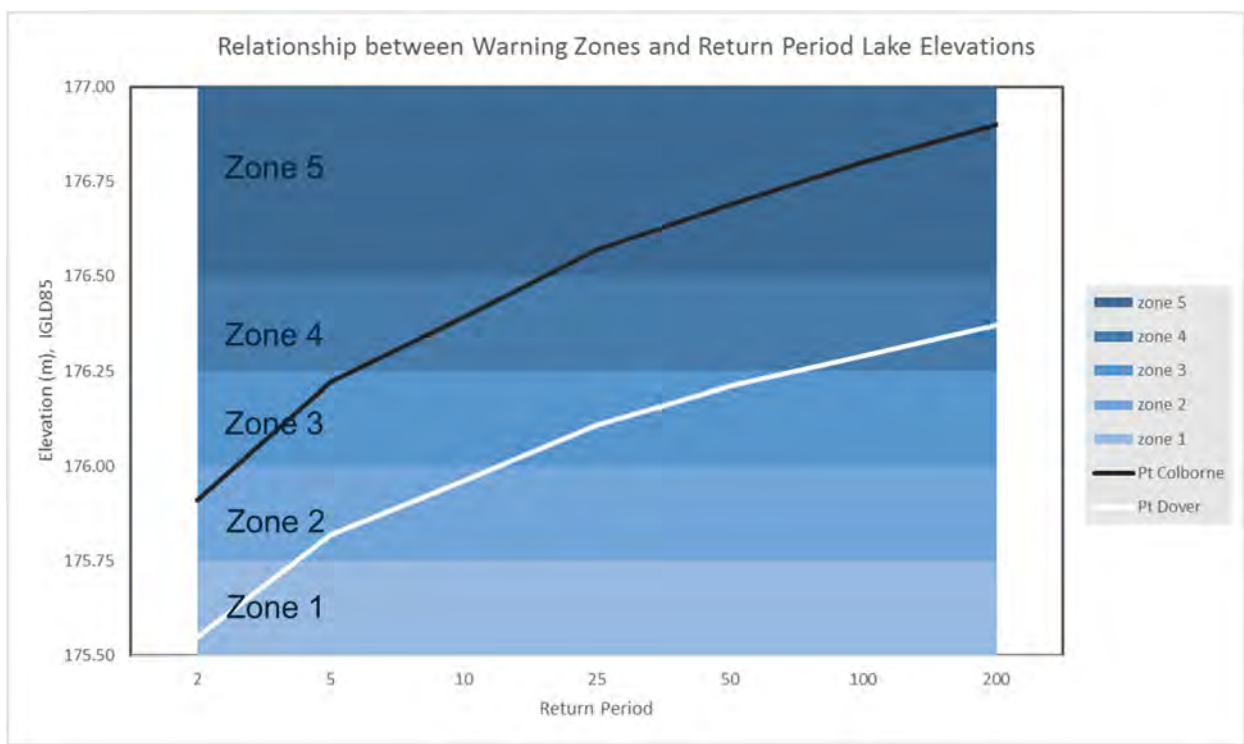
Figure 8.3: Relationship between Haldimand County Lake Erie flood warning stages and return period

LPRCA, GRCA and NPCA issue flood warnings based on the five stages shown in Figure 8.3. The figure also shows the probability of the water levels associated with the stages. Flood levels at the east end of the County

A meeting was held with emergency responders from the County on January 21, 2020 to discuss issues related to emergency response and updates the National Disaster Mitigation Program Risk Assessment Information Template (NDMP RAIT) completed for this project. Based on that meeting, it is our recommendation that the current flood warning stages be maintained. The flood warnings are well understood by emergency responders and the correlation with probabilities of exceedance shown in Figure 8.3 provides additional context.

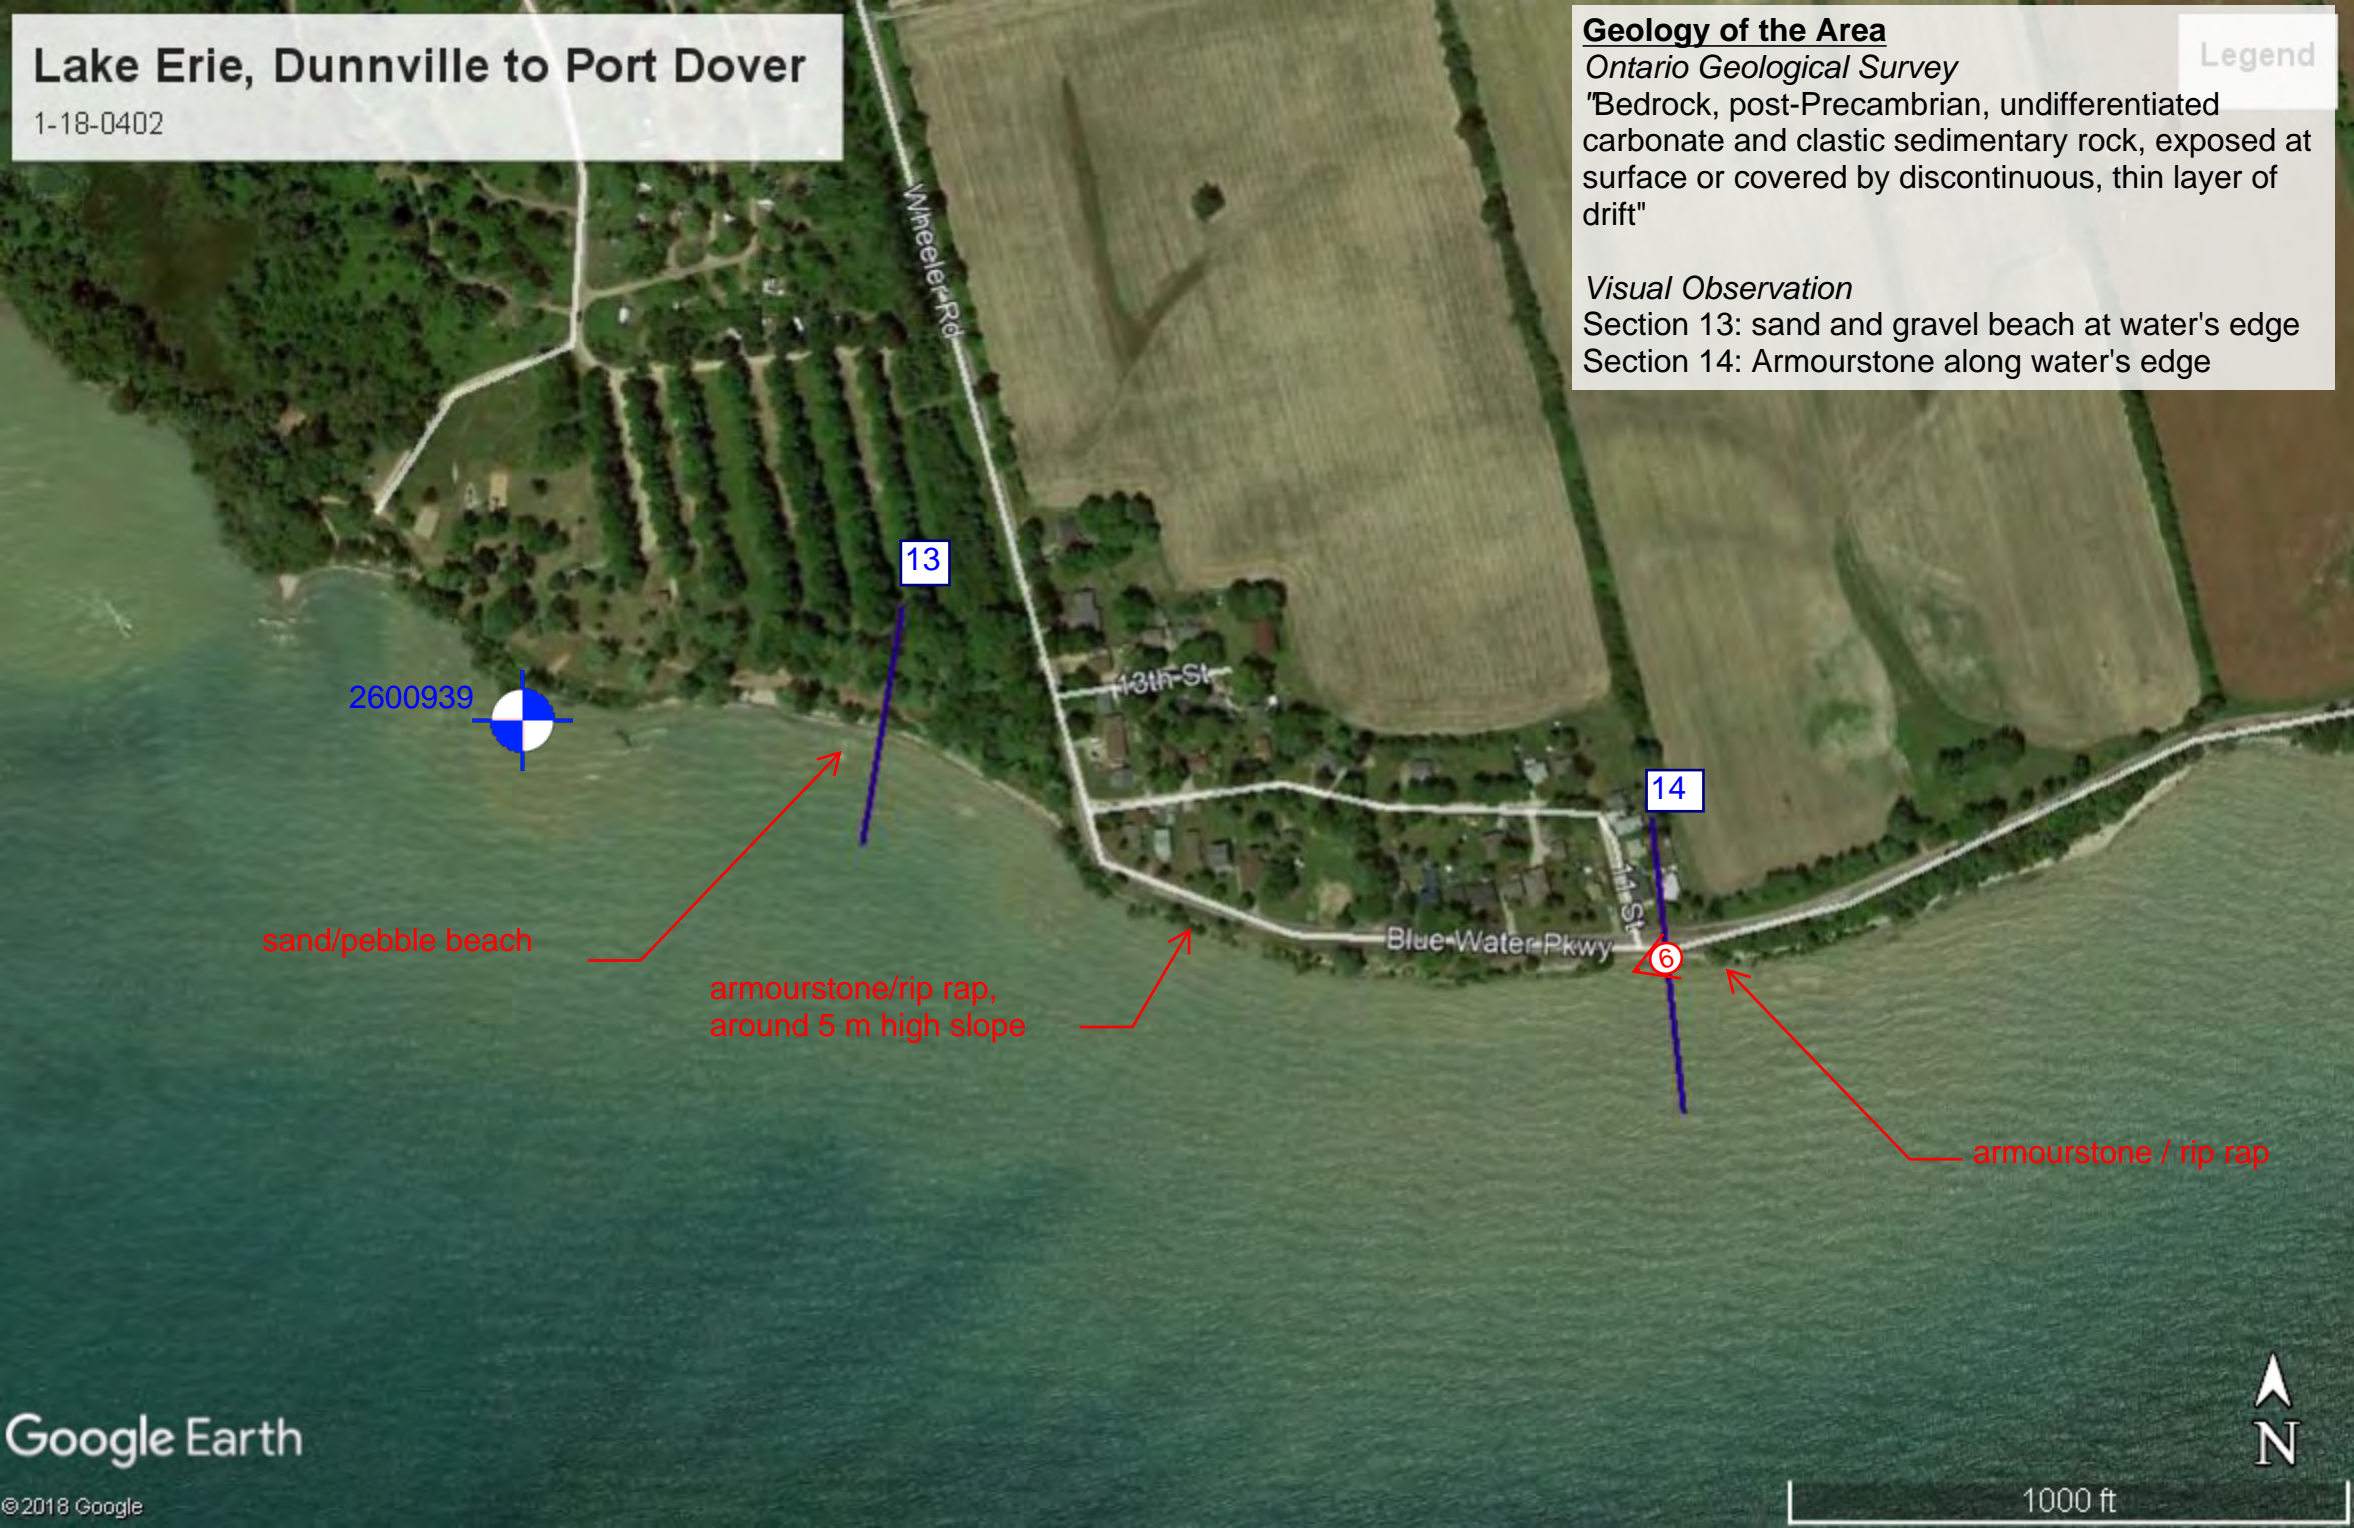
Section 13: sand and gravel beach at water's edge  
Section 14: Armourstone along water's edge

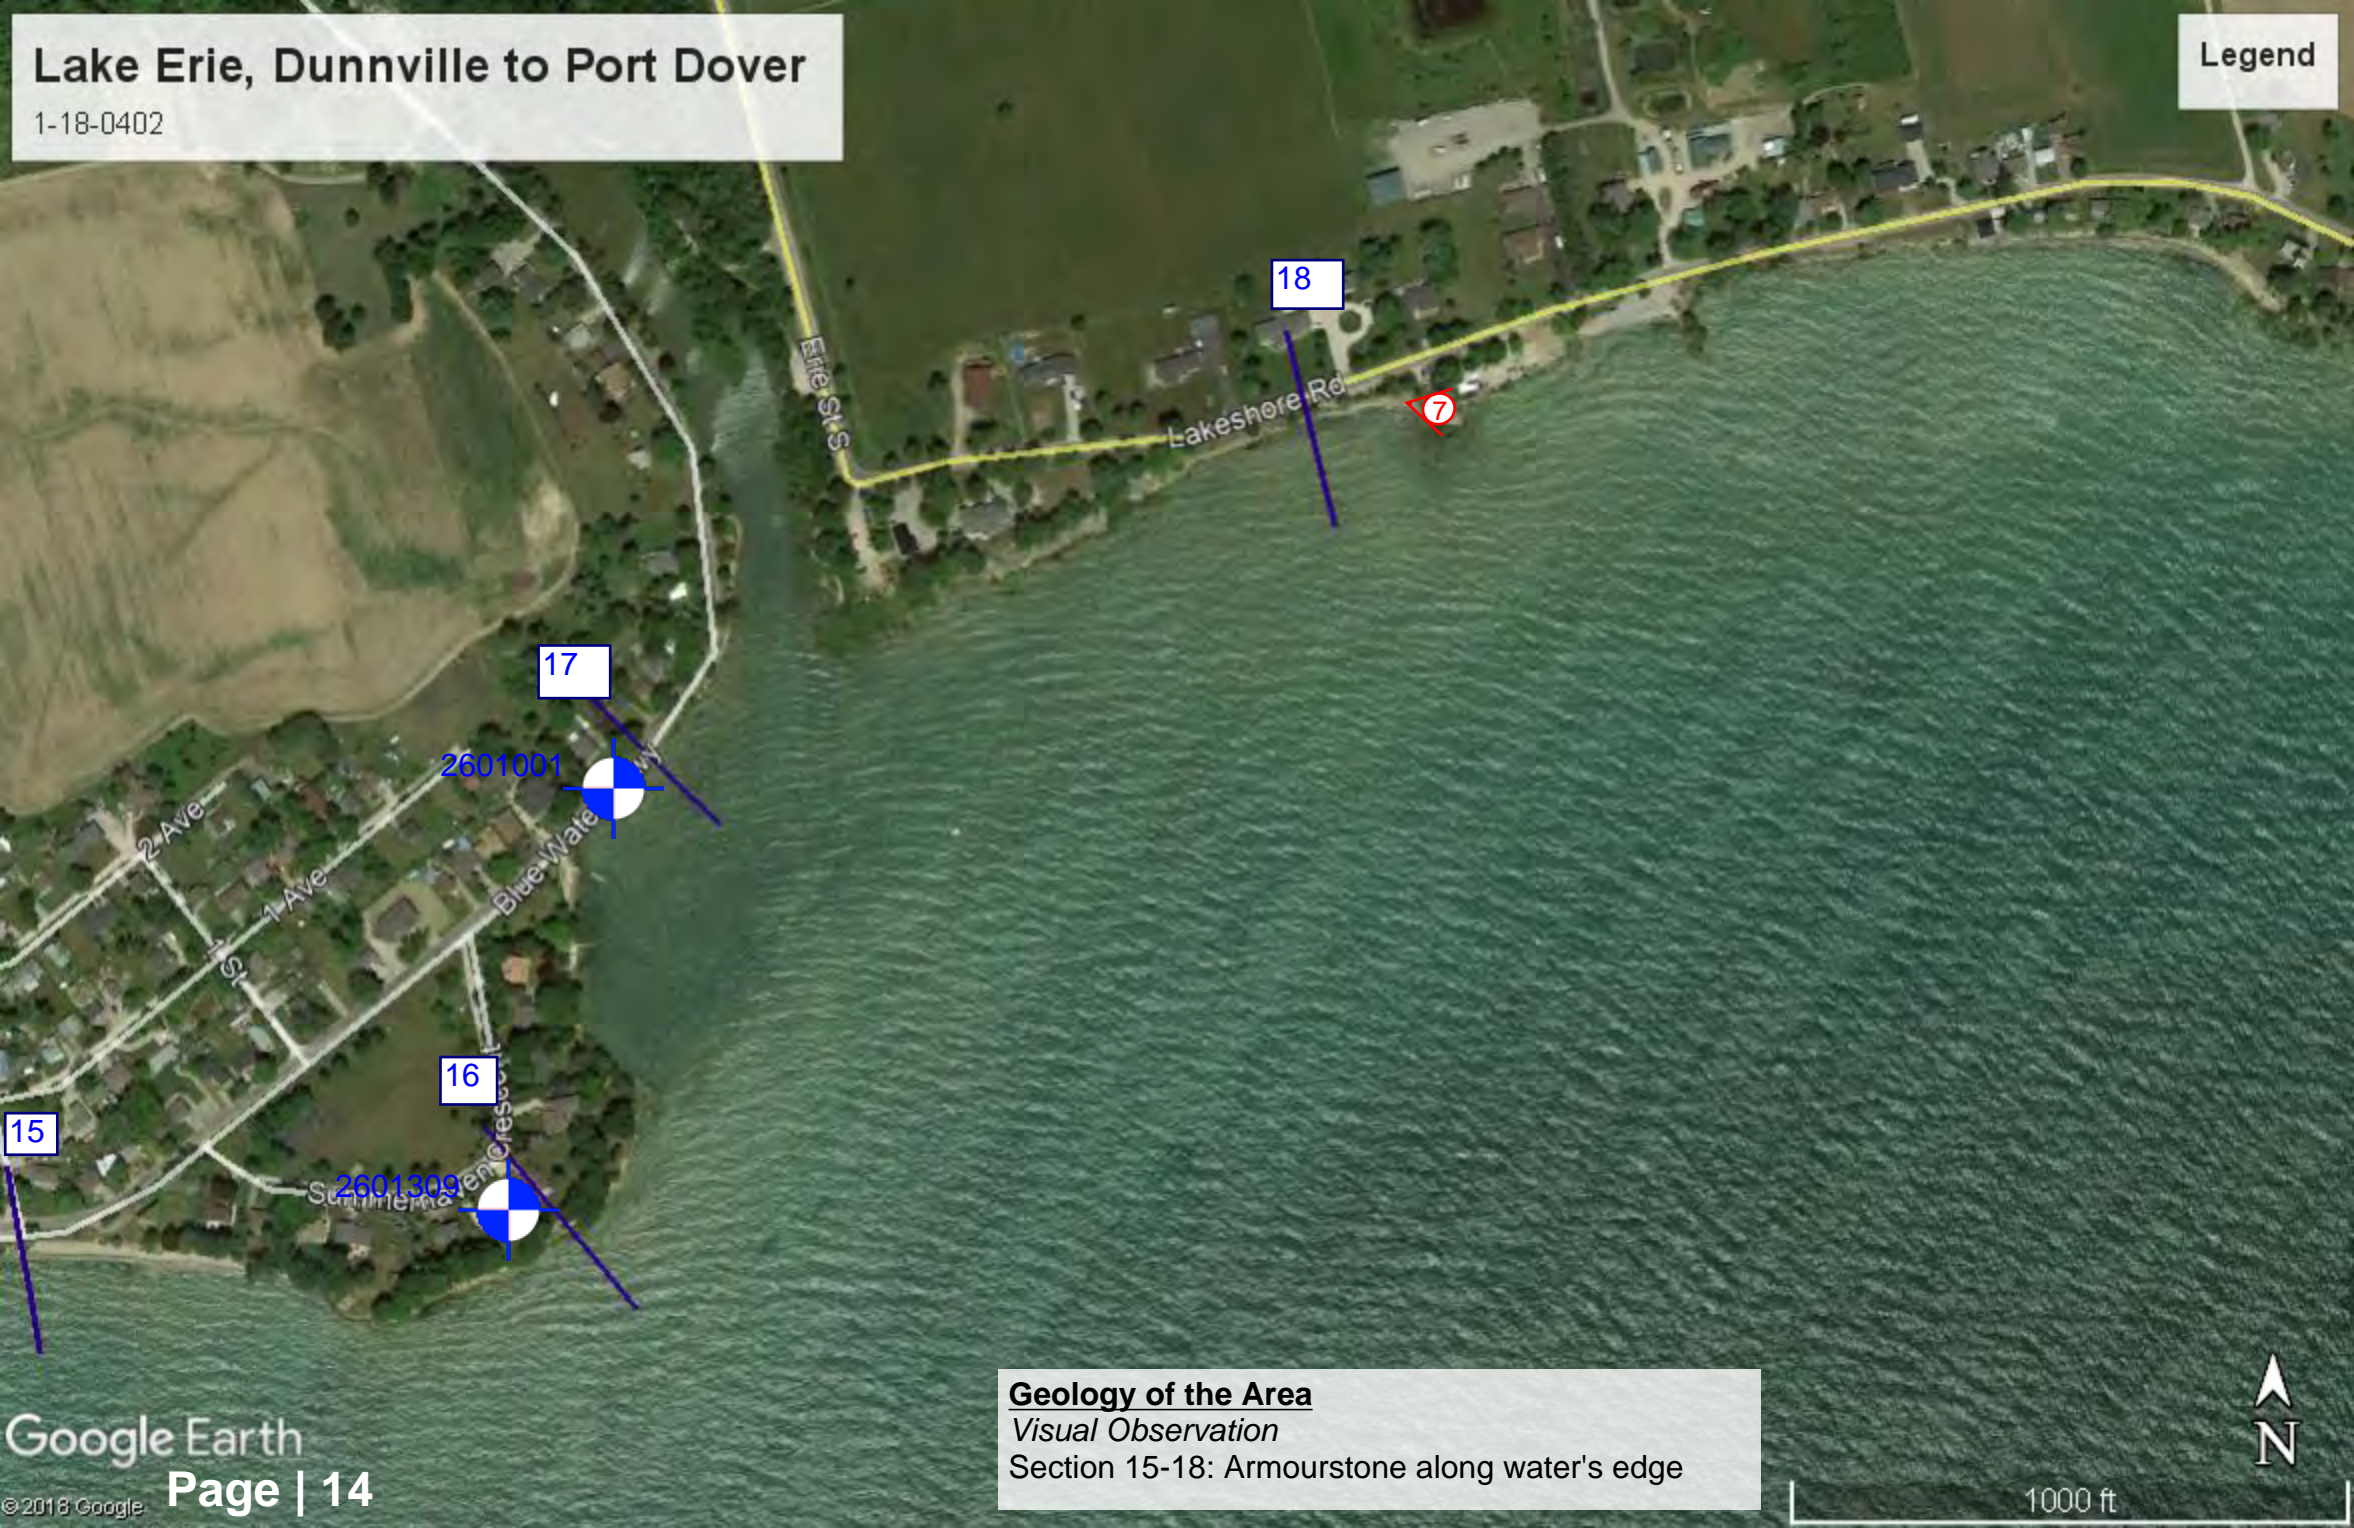
**Geology of the Area**  
*Visual Observation*  
Section 15-18: Armourstone along water's edge

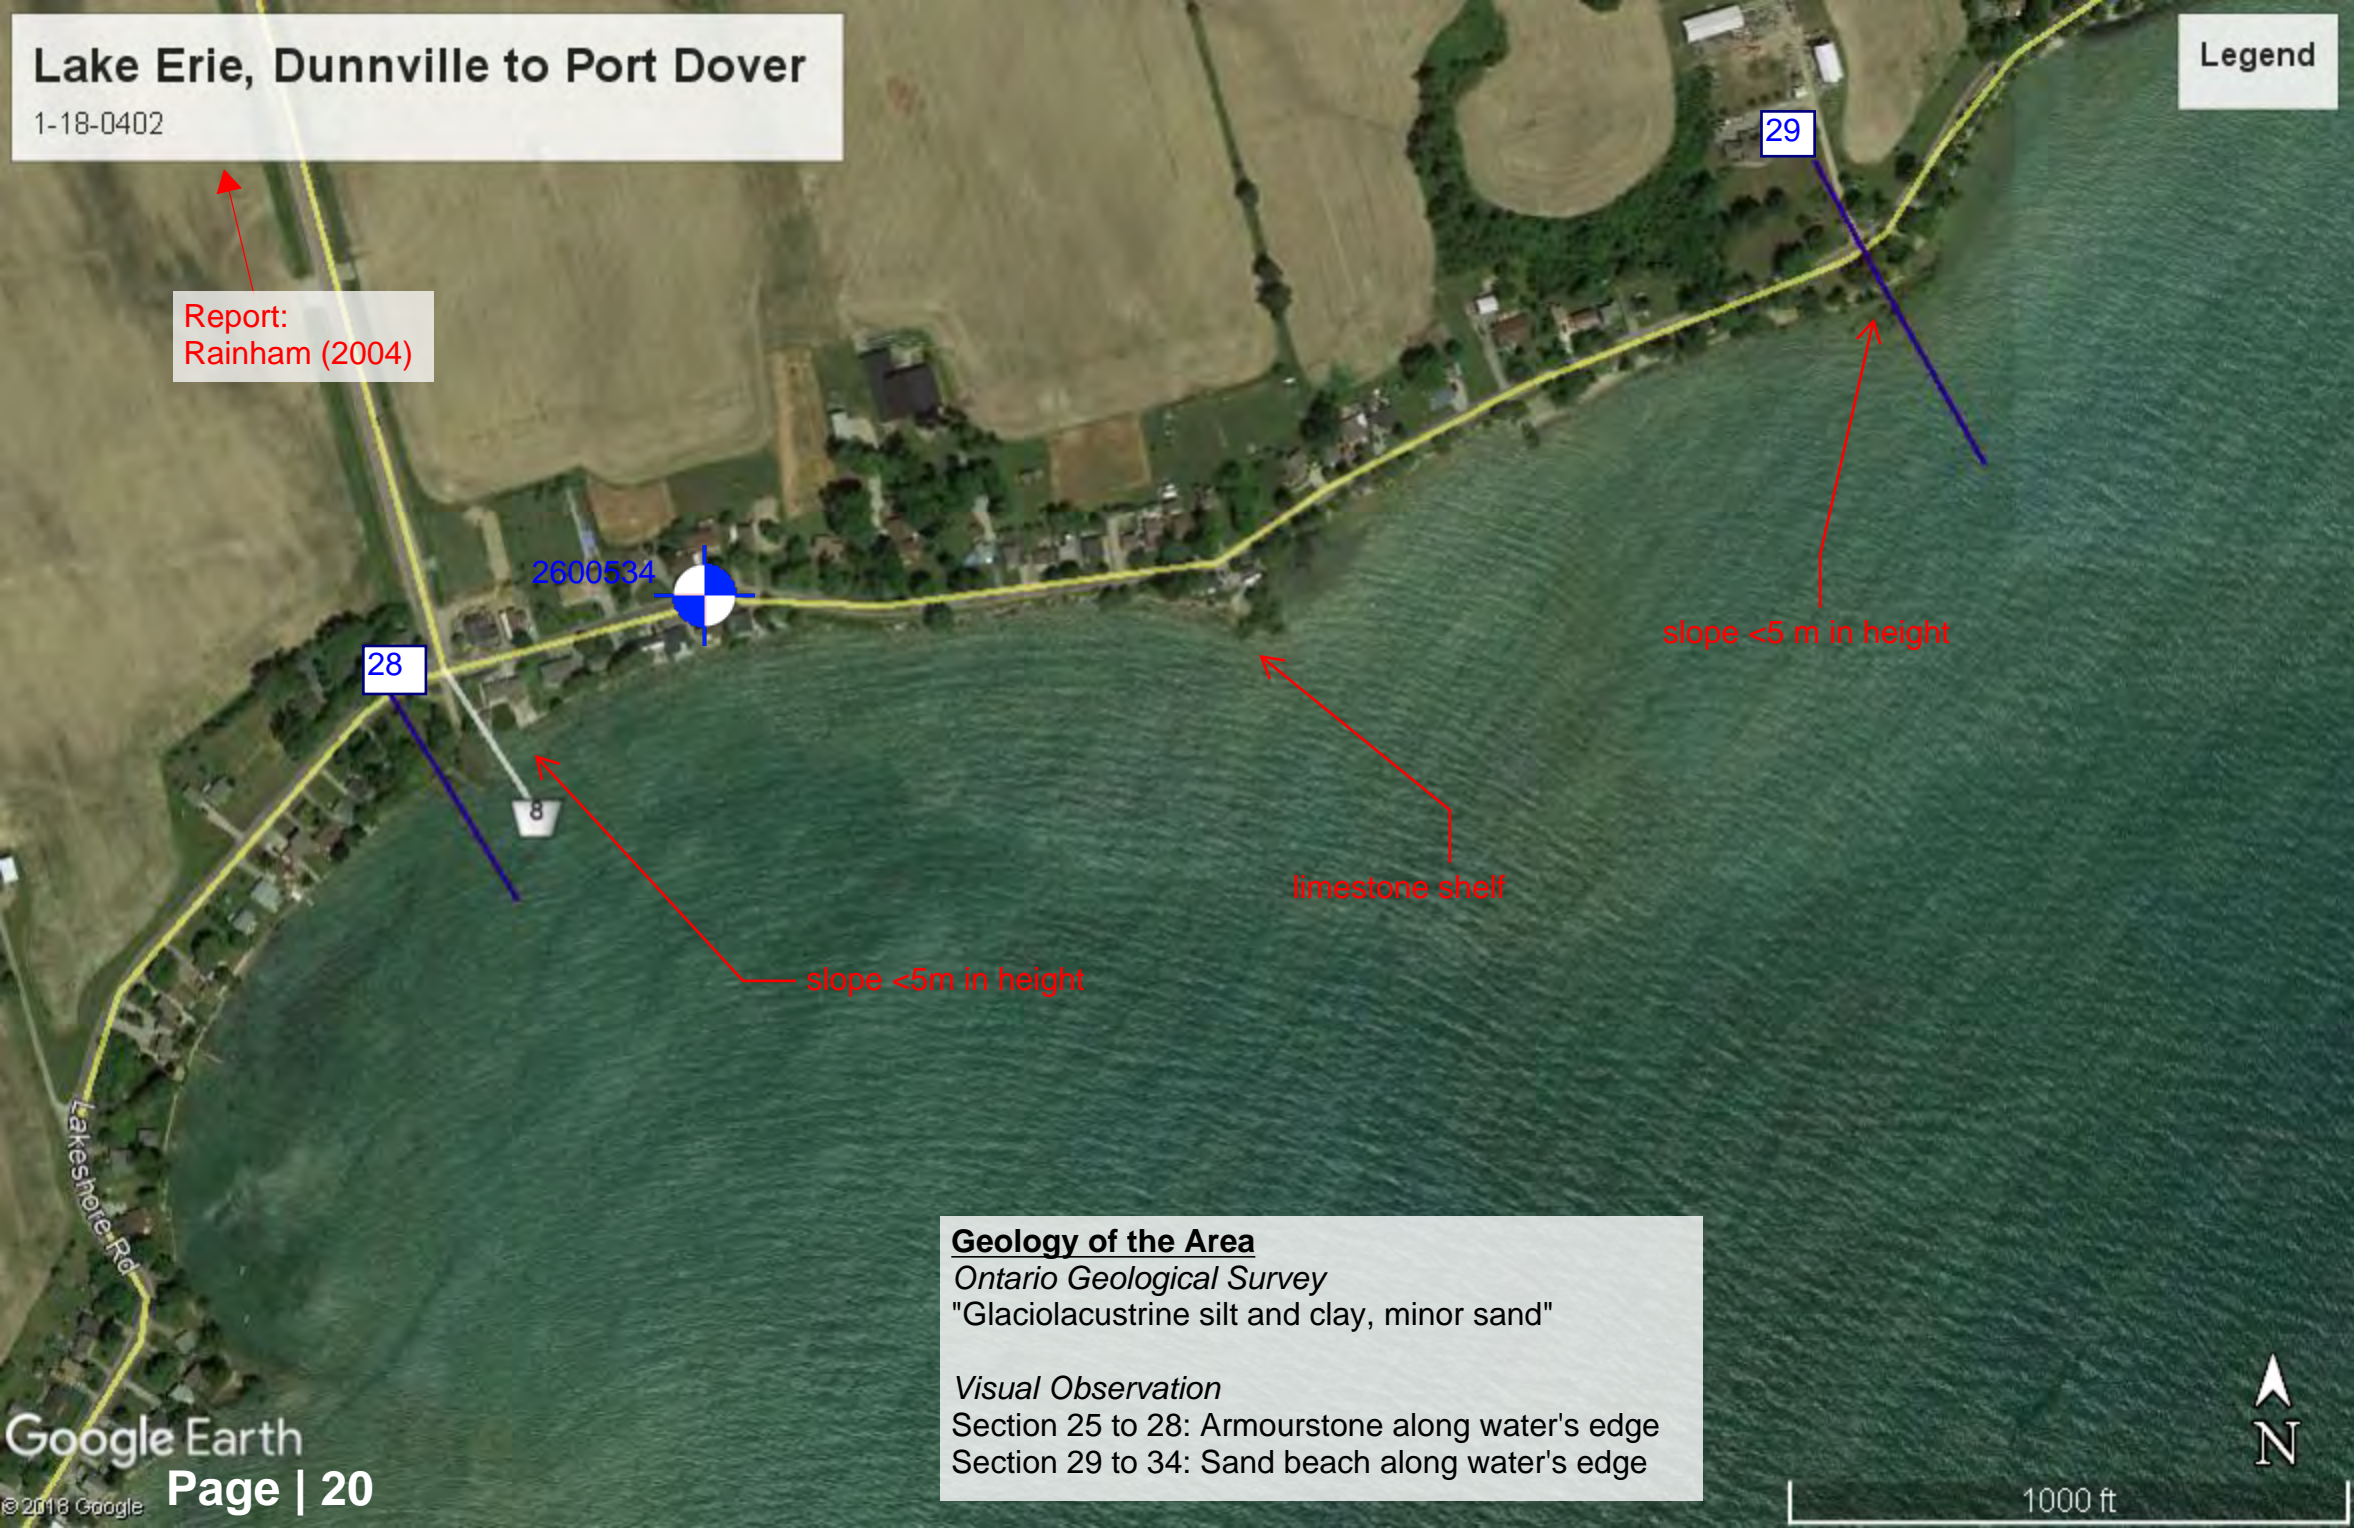
Section 25 to 28: Armourstone along water's edge  
Section 29 to 34: Sand beach along water's edge

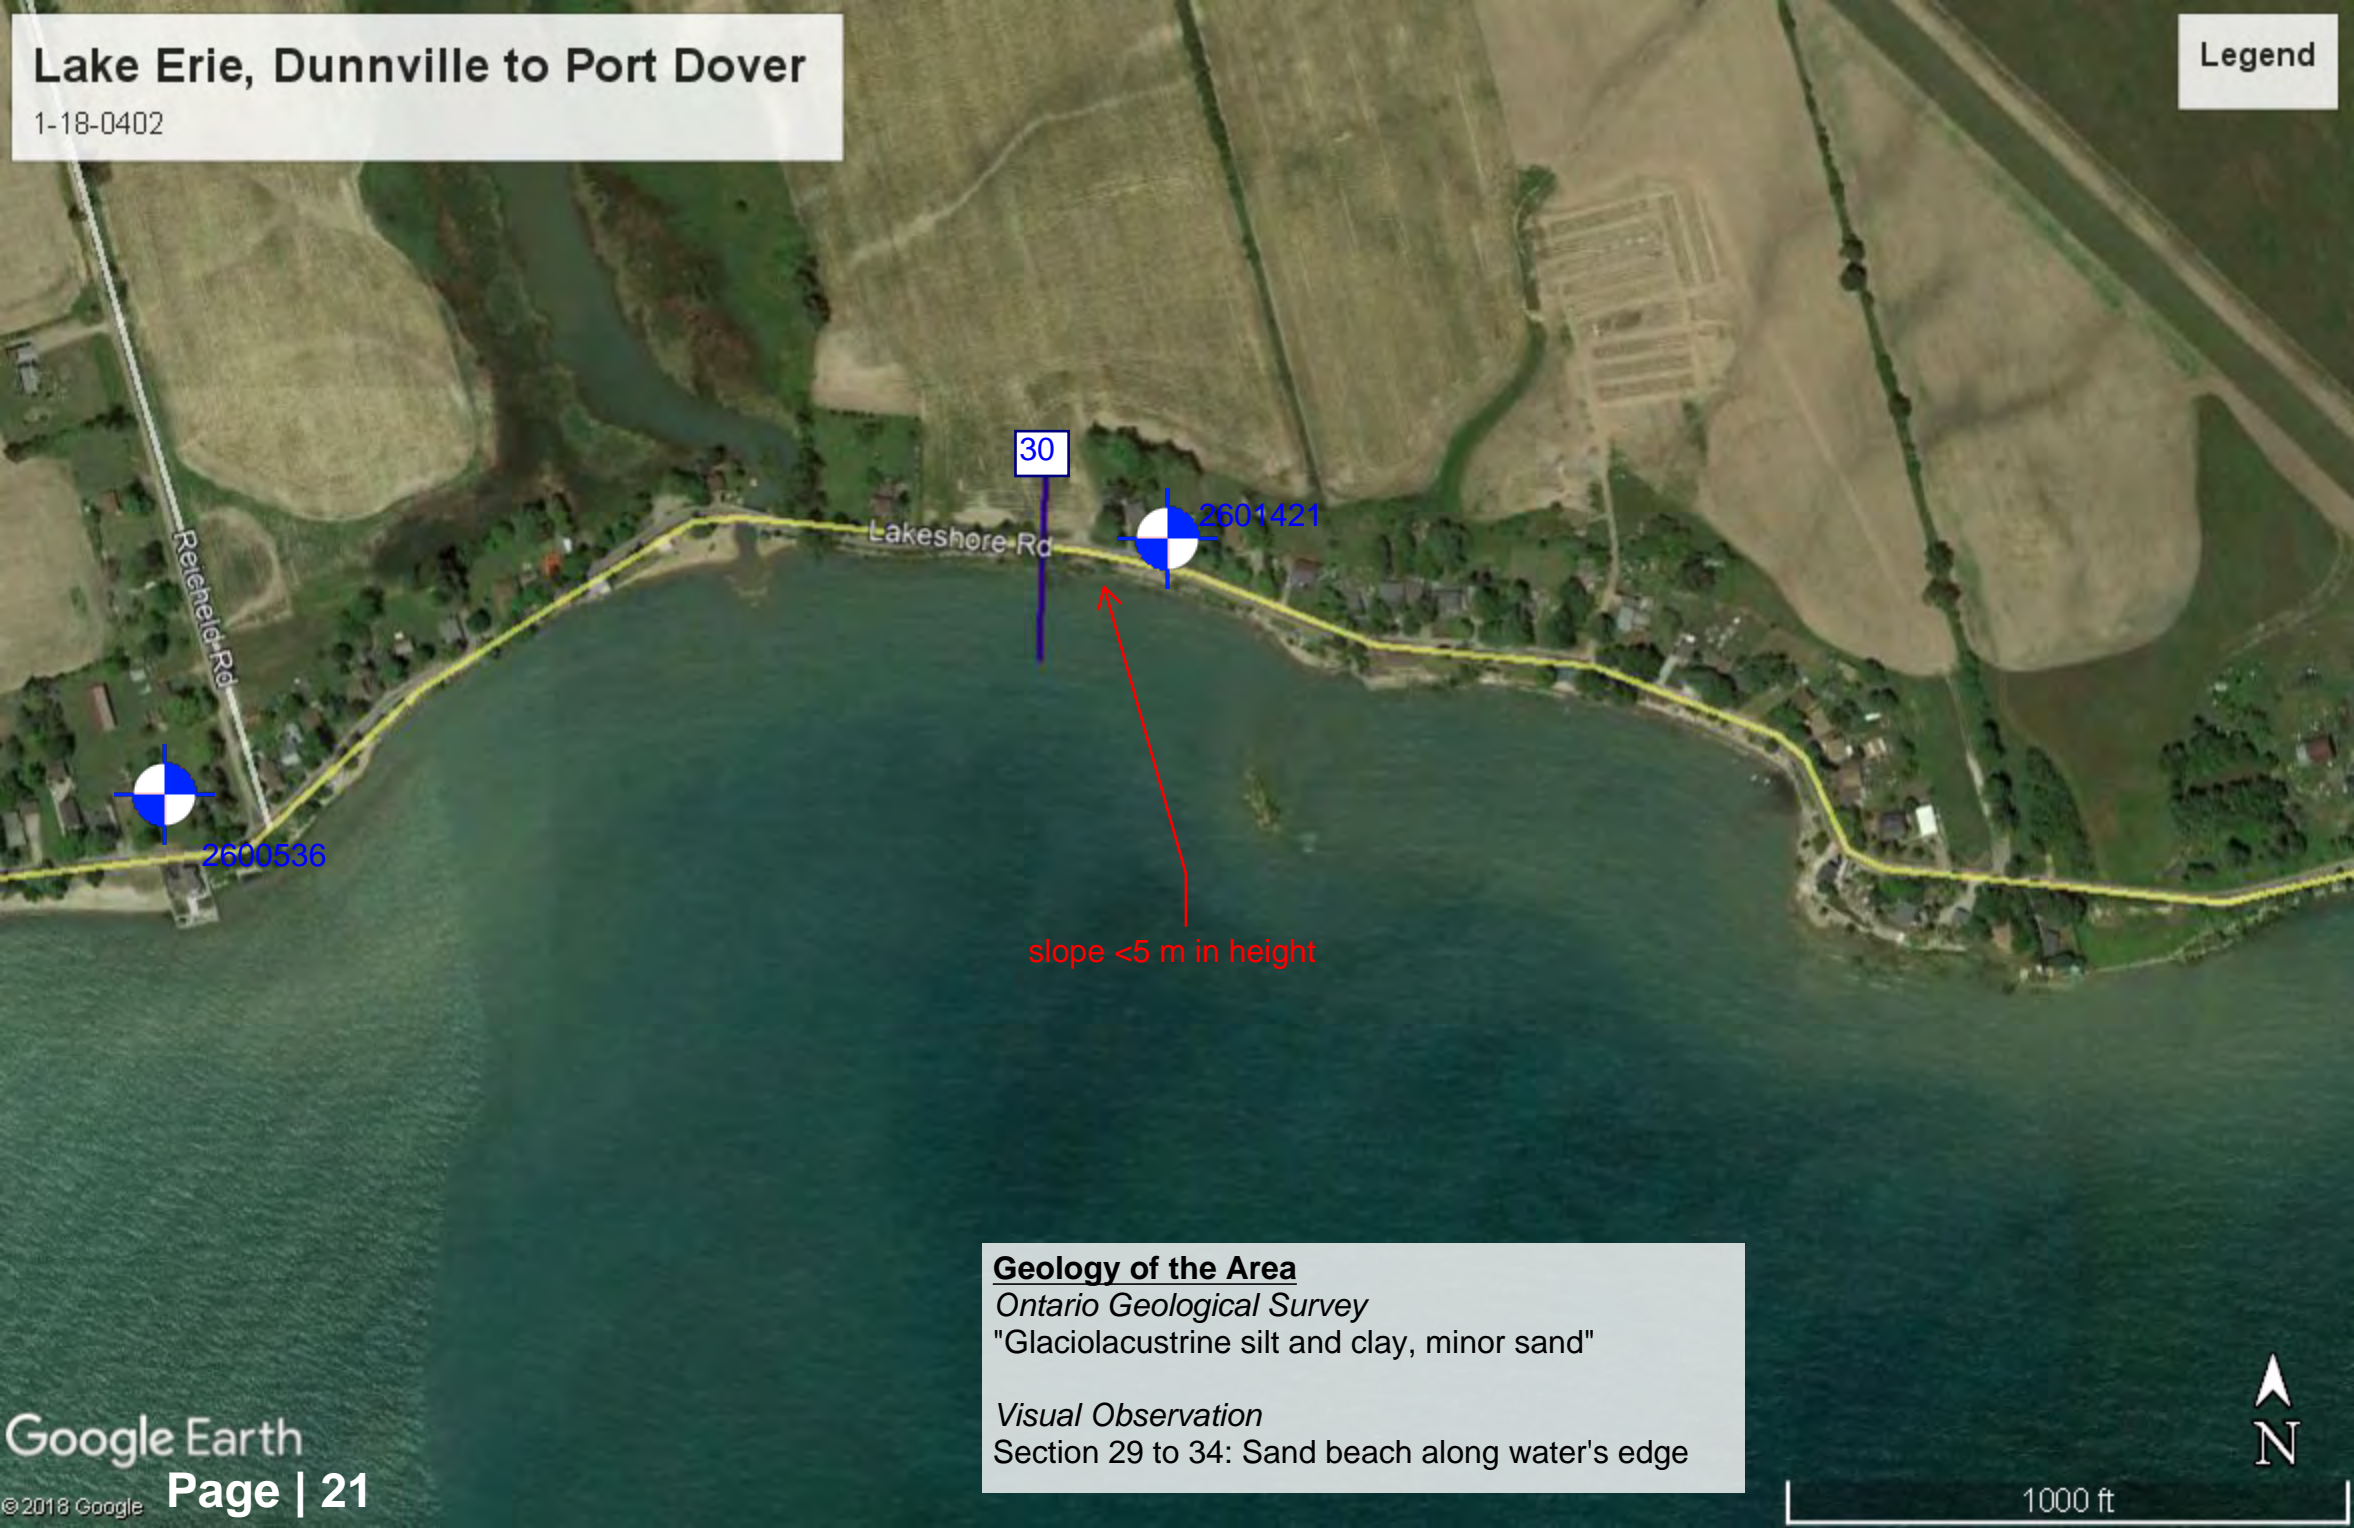
**Geology of the Area**  
Ontario Geological Survey  
"Glaciolacustrine silt and clay, minor sand"

*Visual Observation*  
Section 29 to 34: Sand beach along water's edge
