# Haldimand County Lake Erie Hazard Mapping and Risk Assessment

Technical Report

March 19, 2020 | 12969.101.R2.Rev3

W.F. Baird & Associates Coastal Engineers Ltd.  
and  
Terraprobe Inc.

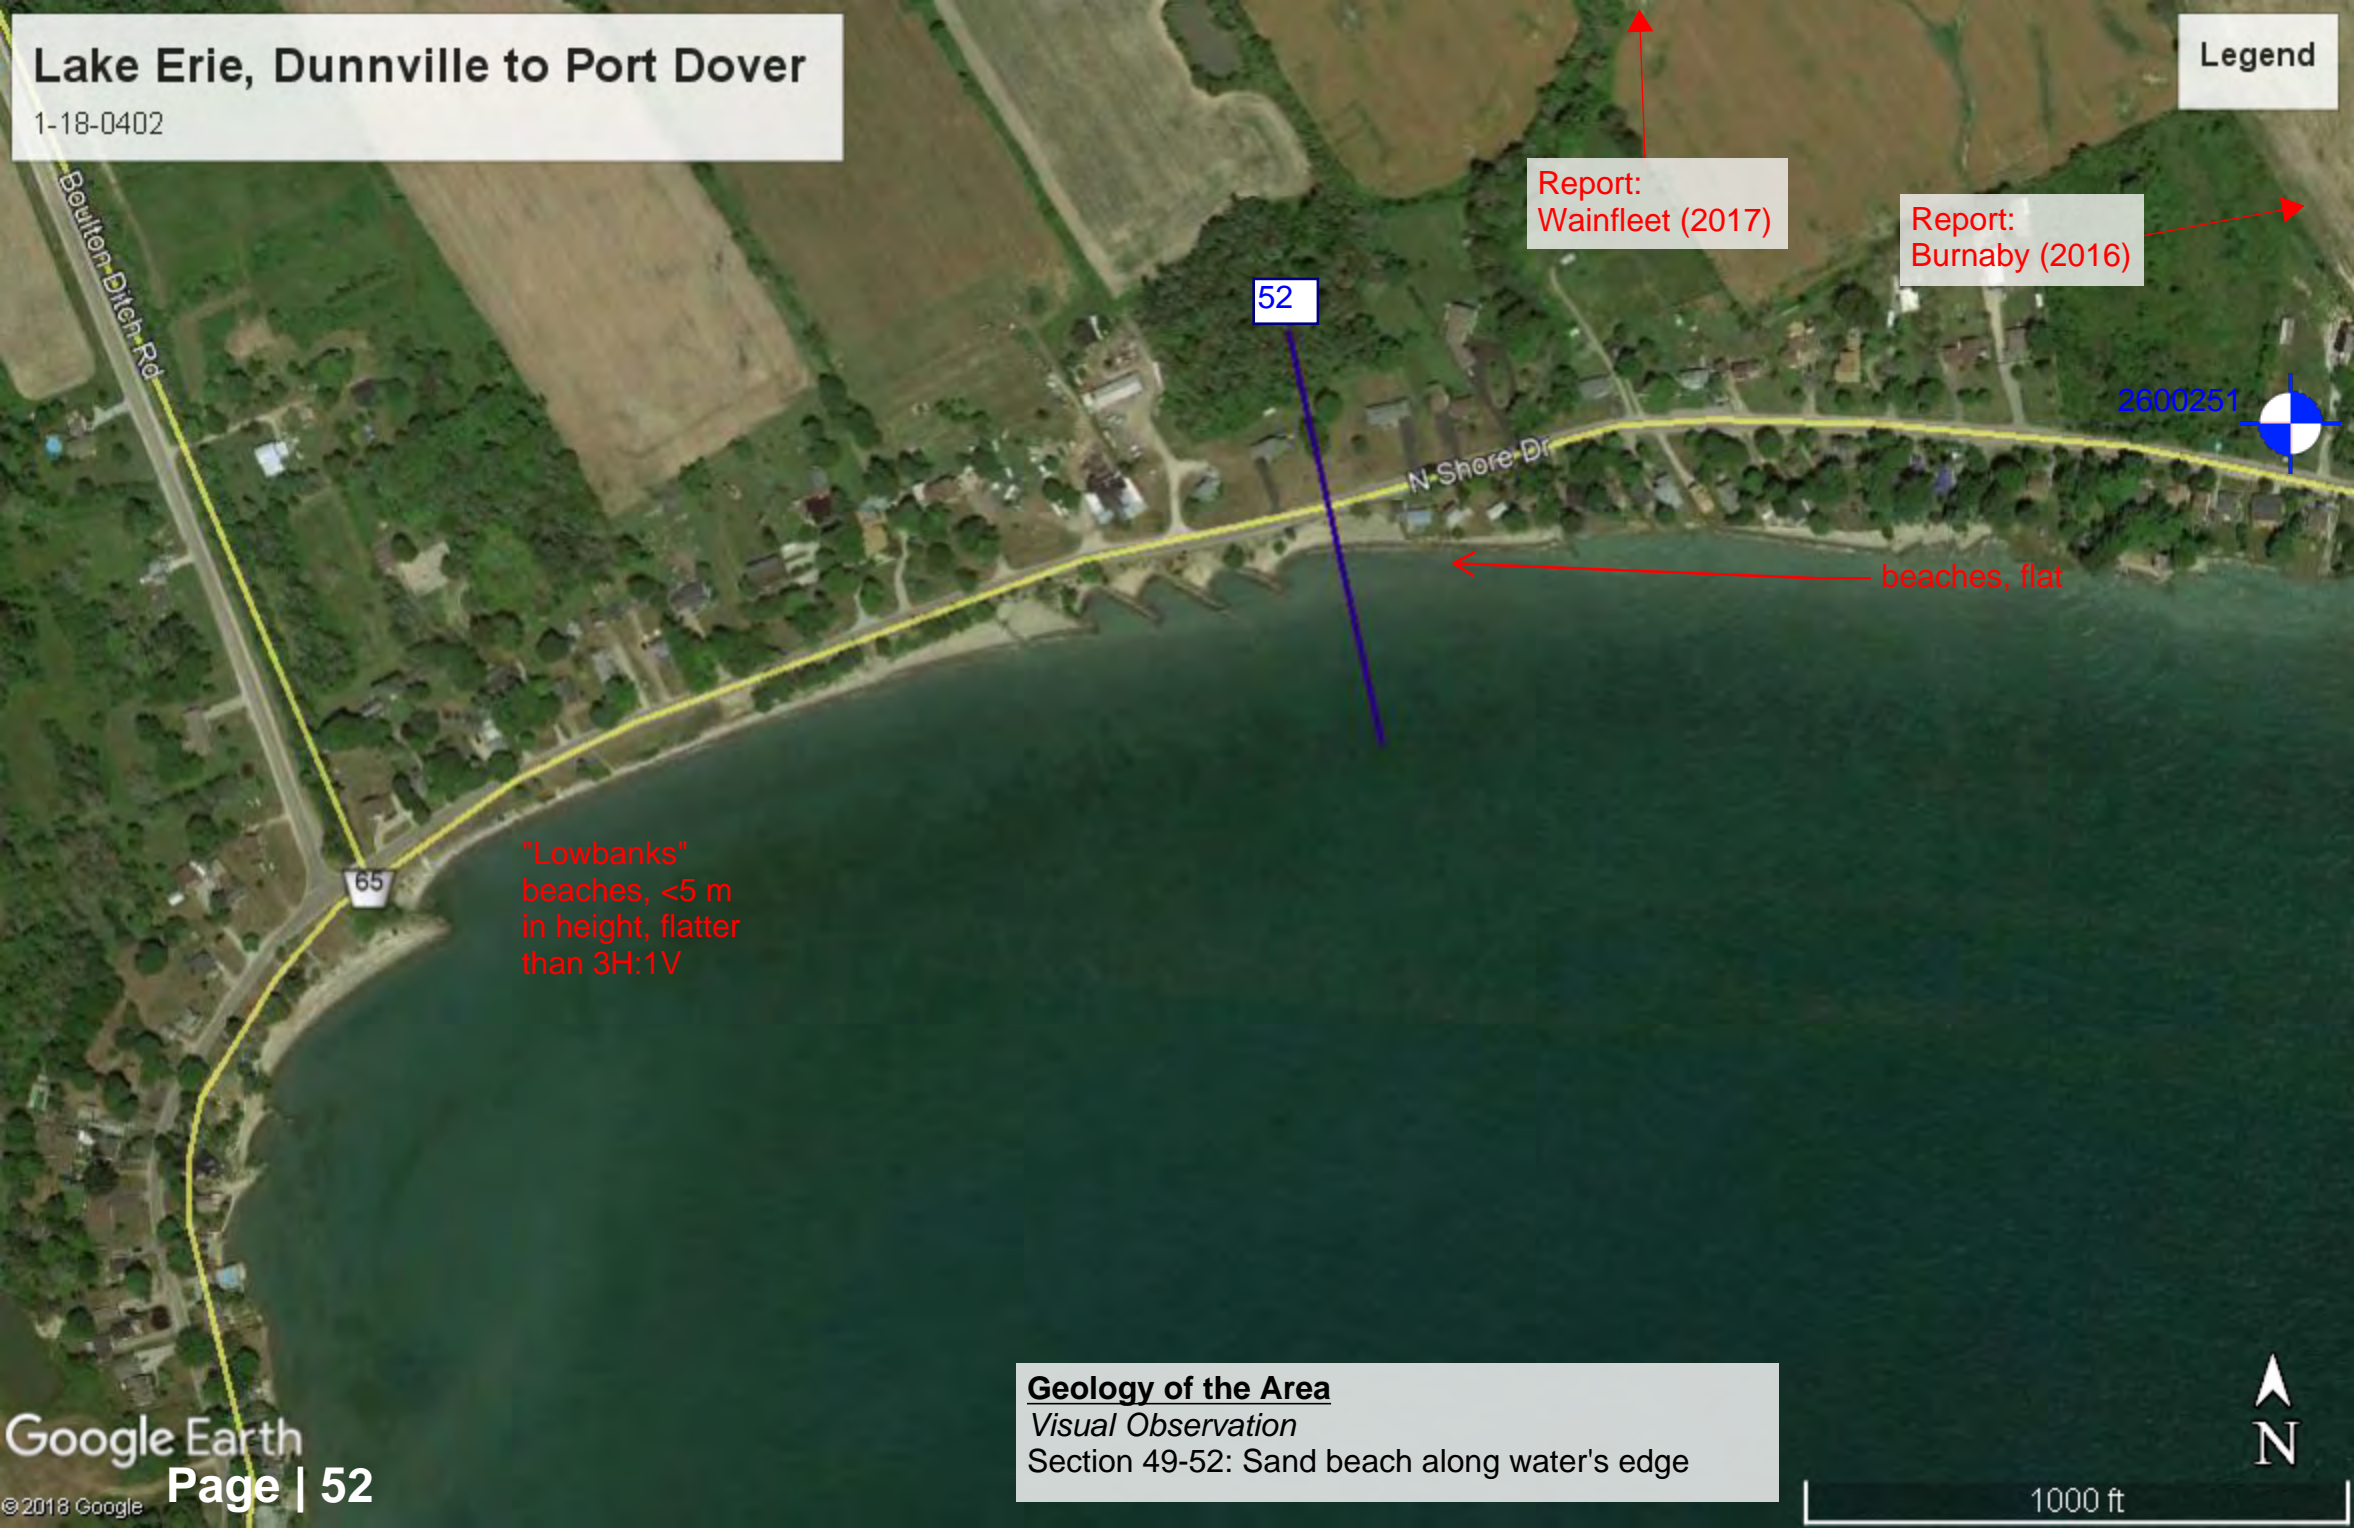
"Lowbanks"  
beaches, <5 m  
in height, flatter  
than 3H:1V

**Geology of the Area**  
*Visual Observation*  
Section 49-52: Sand beach along water's edge

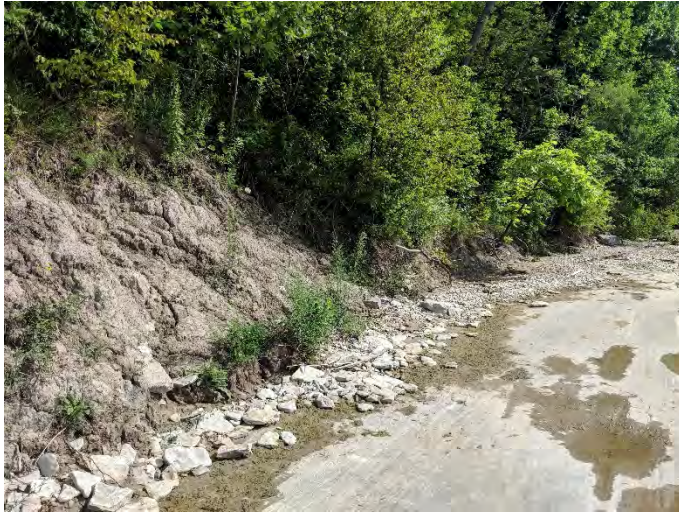
**Photograph 1**

Location: Toe of slope around Section 1  
Viewing: East  
Description: The slope face is forested, the toe of slope is bare. Clayey silt soil is visible. There is a limestone shelf at the toe.

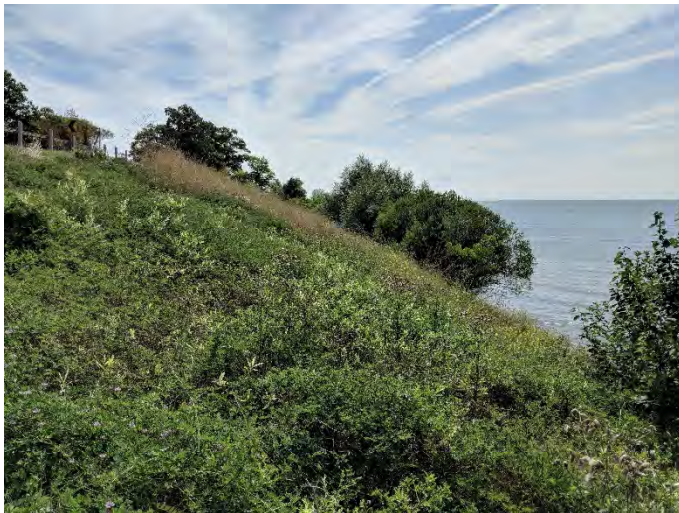
**Photograph 2**

Location: Mid-slope around Section 3  
Viewing: East  
Description: The slope is vegetated with grass. There is an armourstone wall at the toe of slope. No bare soil was observed.

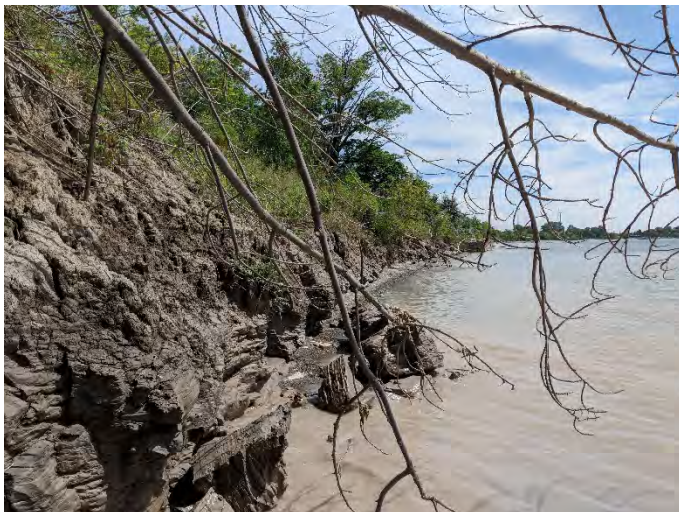
**Photograph 3**

Location: Toe of Section 8  
Viewing: East  
Description: There is an approximately 2 m high erosion scarp at the toe. The soil is clayey silt, trace sand, grey and moist, and layered.

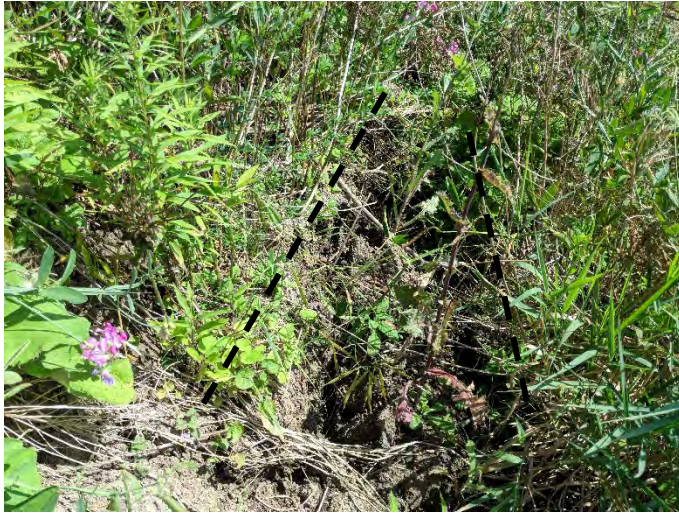
**Photograph 4**

Location: Top of slope around Section 8  
Viewing: East  
Description: There are tension cracks visible in the upper slope face of the slope around Section 8.

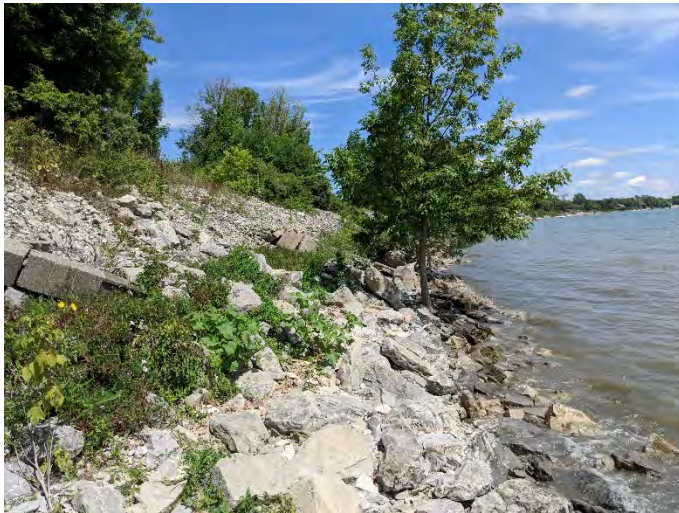
**Photograph 5**

Location: Toe of slope around Section 12  
Viewing: East  
Description: The slope at this section is vegetated with shrubs and young trees. There is rip rap along the toe of slope and slope face.

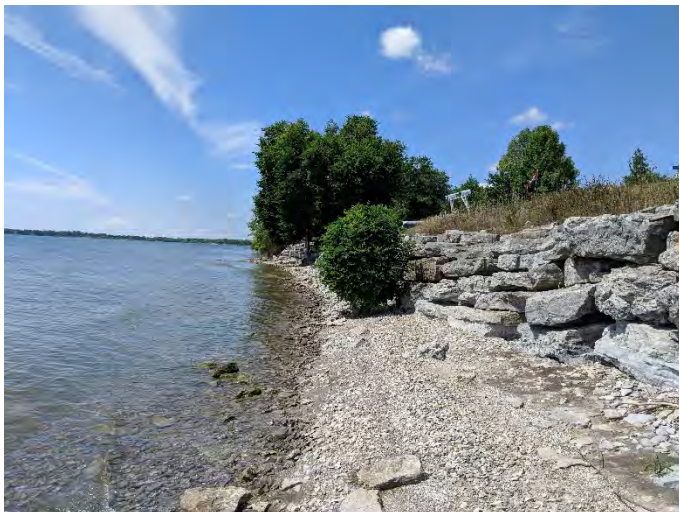
**Photograph 6**

Location: Toe of slope around Section 14  
Viewing: West  
Description: There is an armourstone wall along the toe of slope. The tableland is relatively flat.

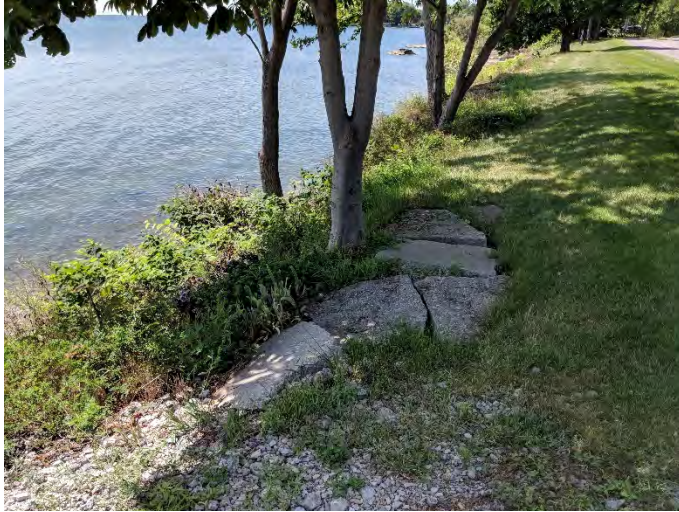
**Photograph 7**

Location: Toe of slope around Section 18  
Viewing: West  
Description: There is rip rap along the toe of slope. The tableland appears to be relatively flat, and vegetated with grass and young trees.

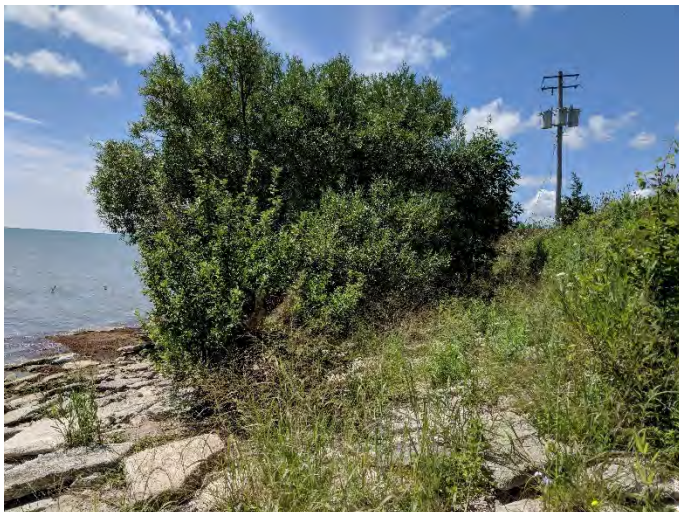
**Photograph 8**

Location: Slope around Section 23  
Viewing: West  
Description: There is sand at the toe of slope. The shoreline is vegetated with grass and shrubs.

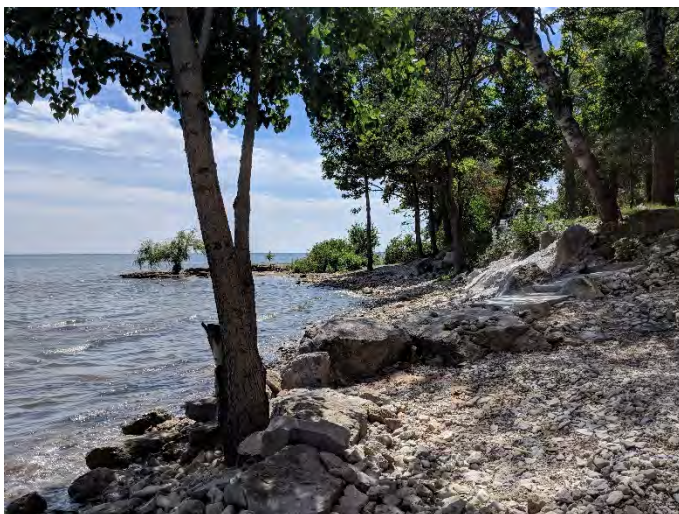
**Photograph 9**

Location: Between Section 31 and 32  
Viewing: West  
Description: There is a sand and pebble beach along the shoreline. The tableland is vegetated with grass, and mature to young trees.

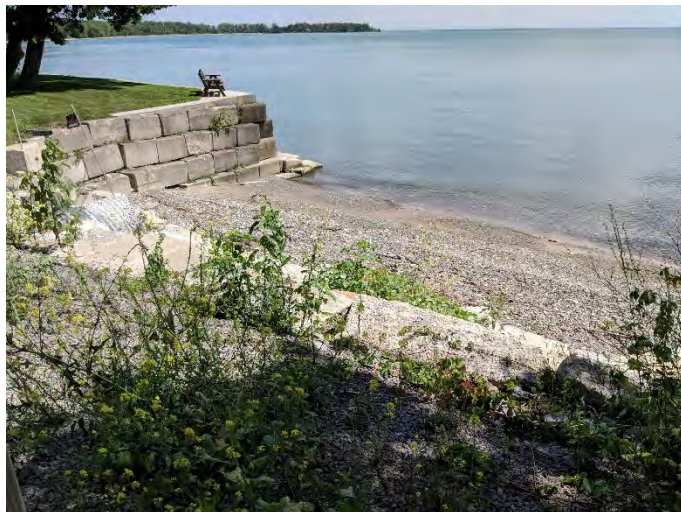
**Photograph 10**

Location: Slope around Section 39  
Viewing: East  
Description: There is an approximately a 5 m high slope at the shoreline with erosion protection. The tableland is vegetated with grass.

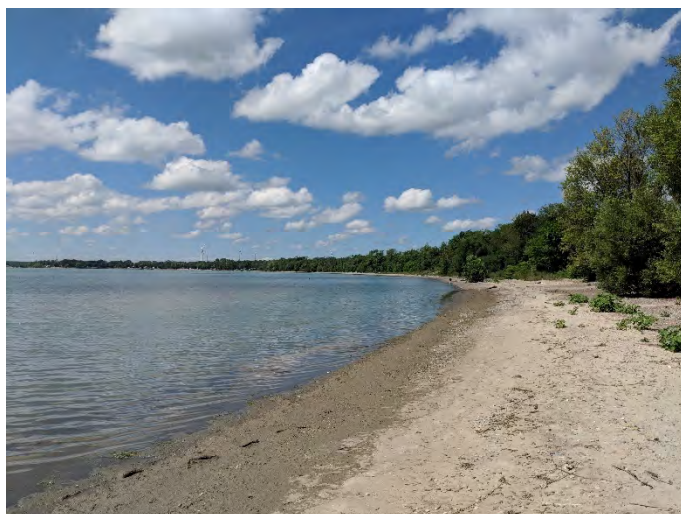
**Photograph 11**

Location: Slope around Section 40  
Viewing: West  
Description: There is a sand beach around Section 40.

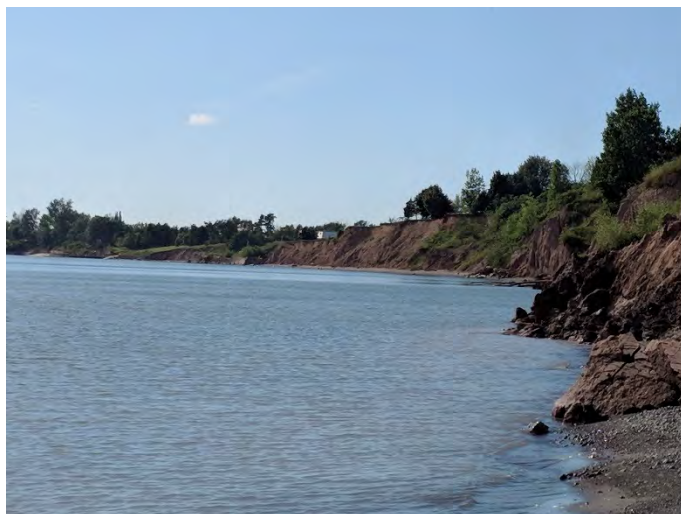
**Photograph 12**

Location: Slope around Section 45  
Viewing: East  
Description: There are glacial till bluffs at the shoreline. The bluffs at Section 45 are near vertical. The glacial till is a reddish brown sand and silt, with some clay, trace gravel trace cobbles, moist, and dense.

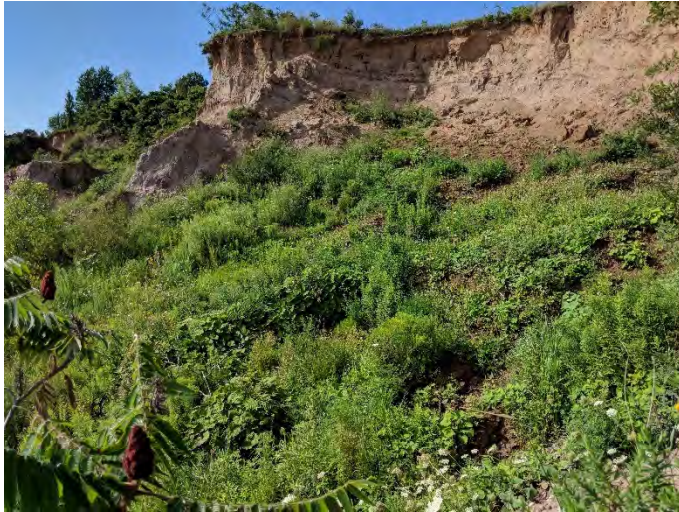
**Photograph 13**

Location: Slope at Section 46  
Viewing: North  
Description: There is a near vertical scarp in the upper slope face, with talus accumulation on the mid to lower slope face. The talus is vegetated with grass and shrubs.

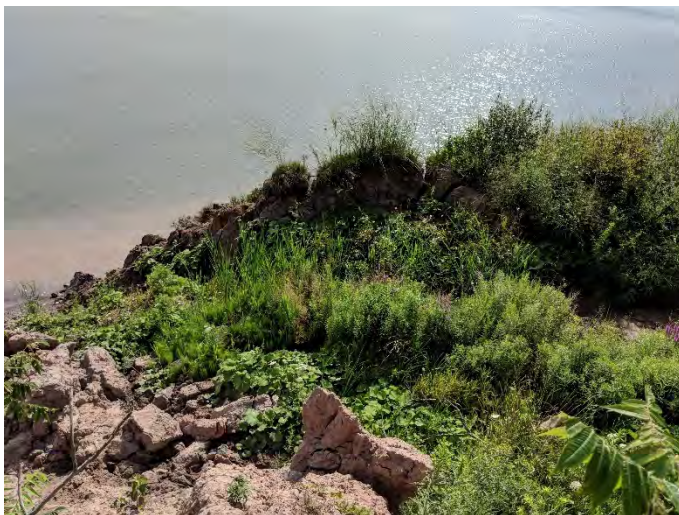
**Photograph 14**

Location: Slope at Section 46  
Viewing: Slope  
Description: Talus accumulation at the toe of slope along the shoreline at Section 46.

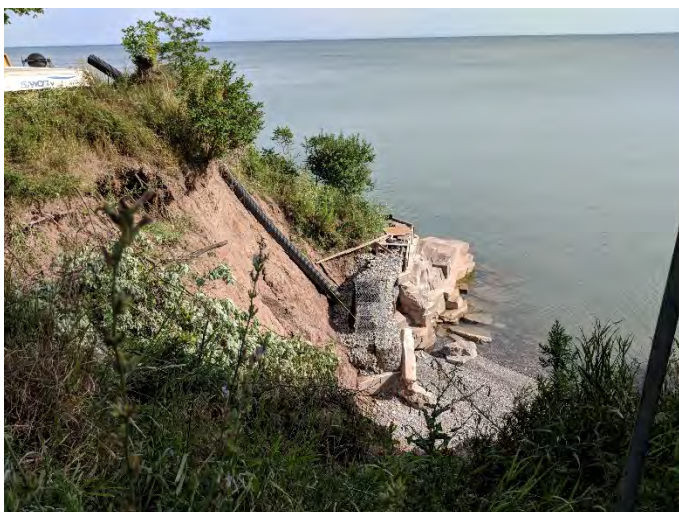
**Photograph 15**

Location: Slope at Dickout Road  
Viewing: Gabion and Limestone retaining walls  
Description: At the end of Dickout Road there is construction of retaining walls at the toe of slope, with a drainage pipe down the slope face. The retaining walls are up to 6-7 m in height.

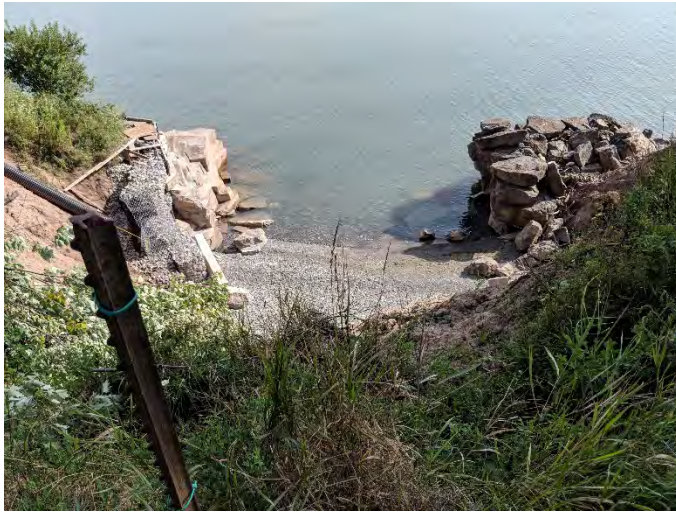
**Photograph 16**

Location: Slope at Dickout Road  
Viewing: Retaining walls  
Description: There is a limestone toe wall across from the gabion stone wall up to approximately 5 m in height. There is a gravel beach in between the two walls.

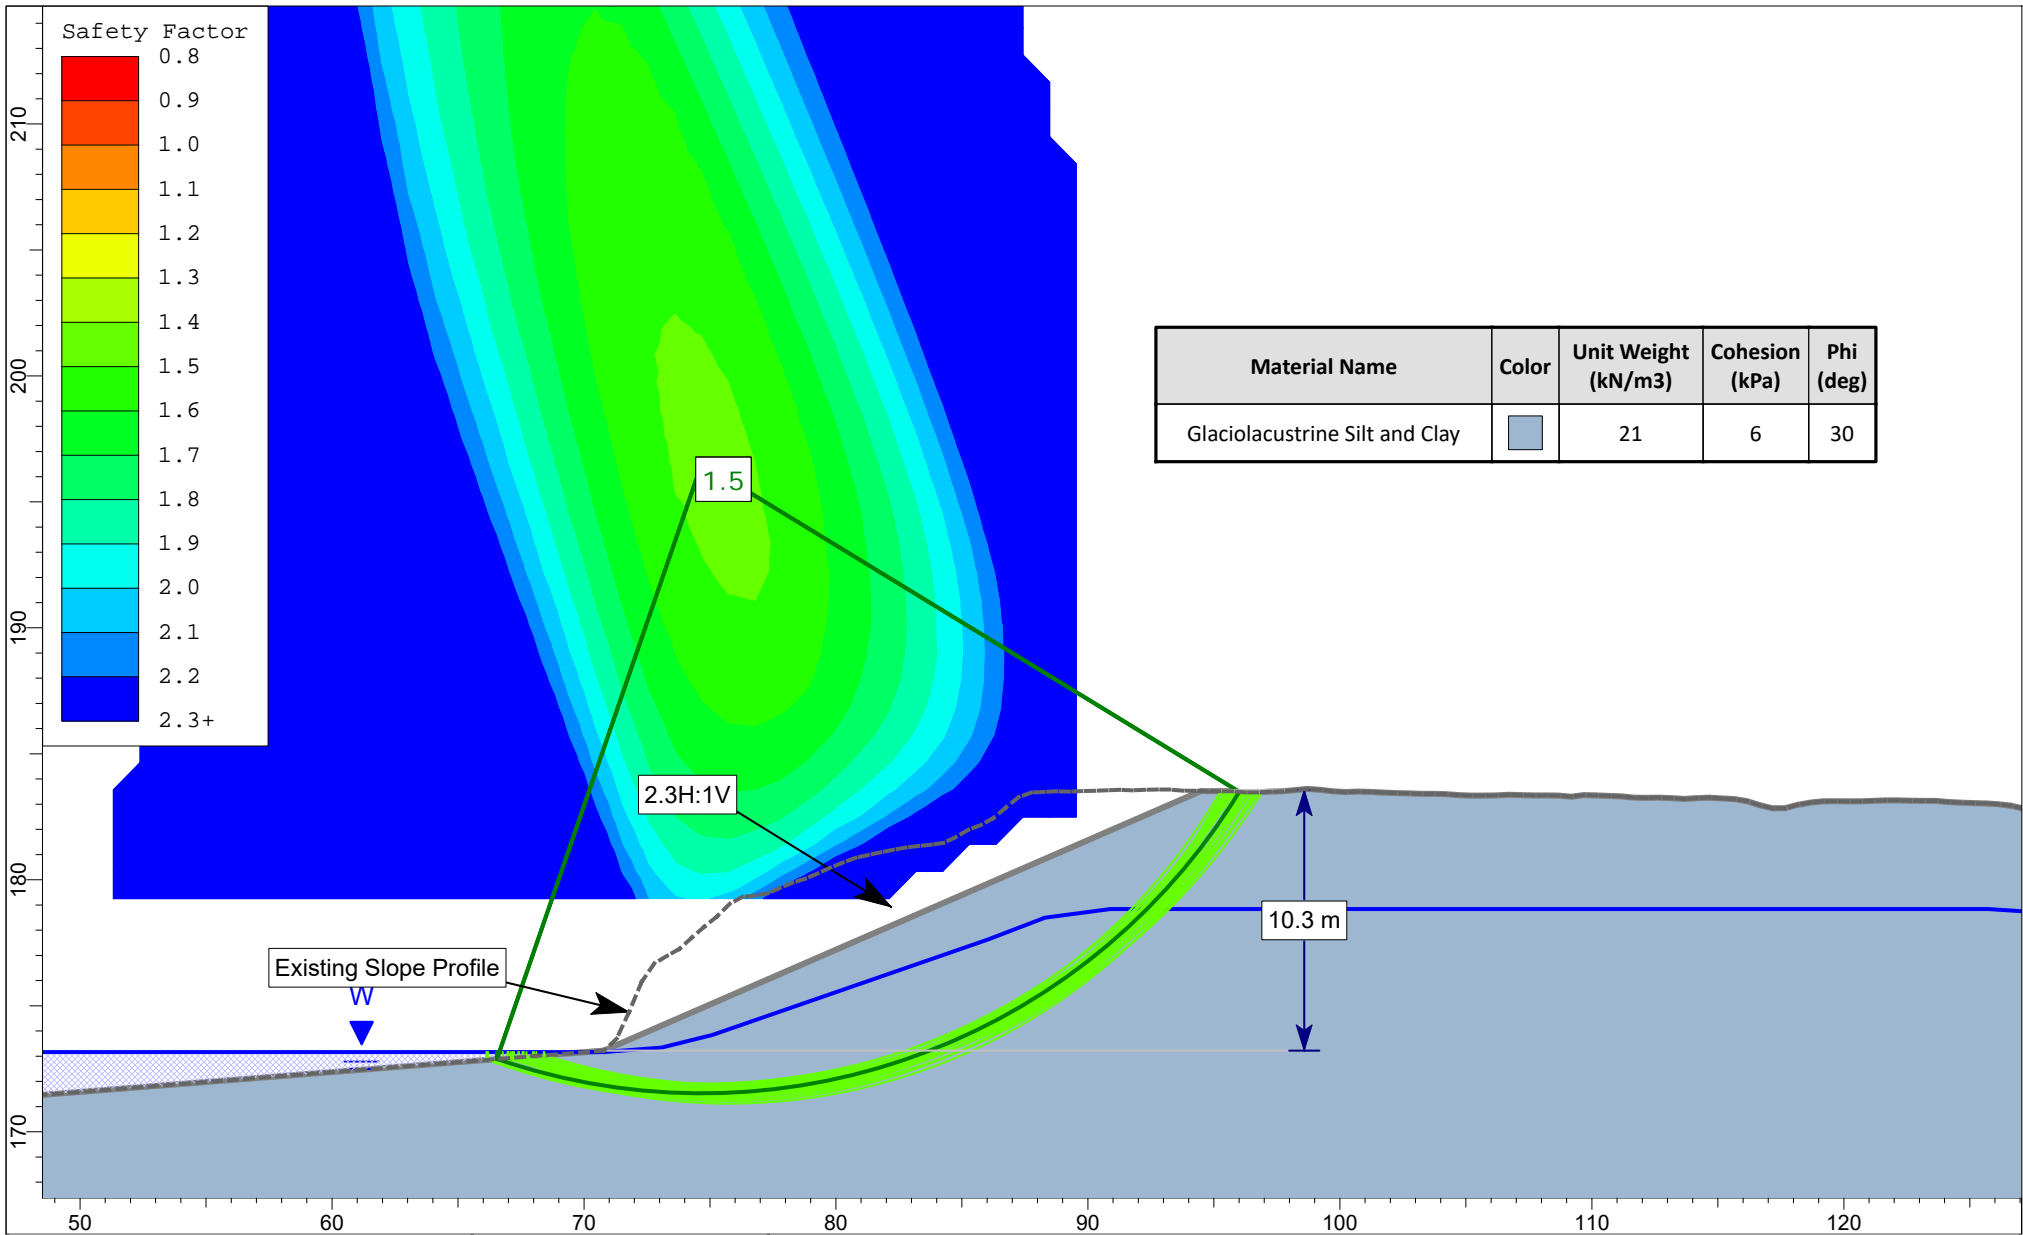
Project <b>Halimand County Slope Stability   1-18-0402-01</b>		
Analysis Global Stability: Section 3 - SSI, high gwt		
Date 5/14/2019	Scale 1:300	File Halimand Part 1 v2.slm
By JH/JC	Ref. 2017 LiDar data, provided by Baird on March 13, 2019

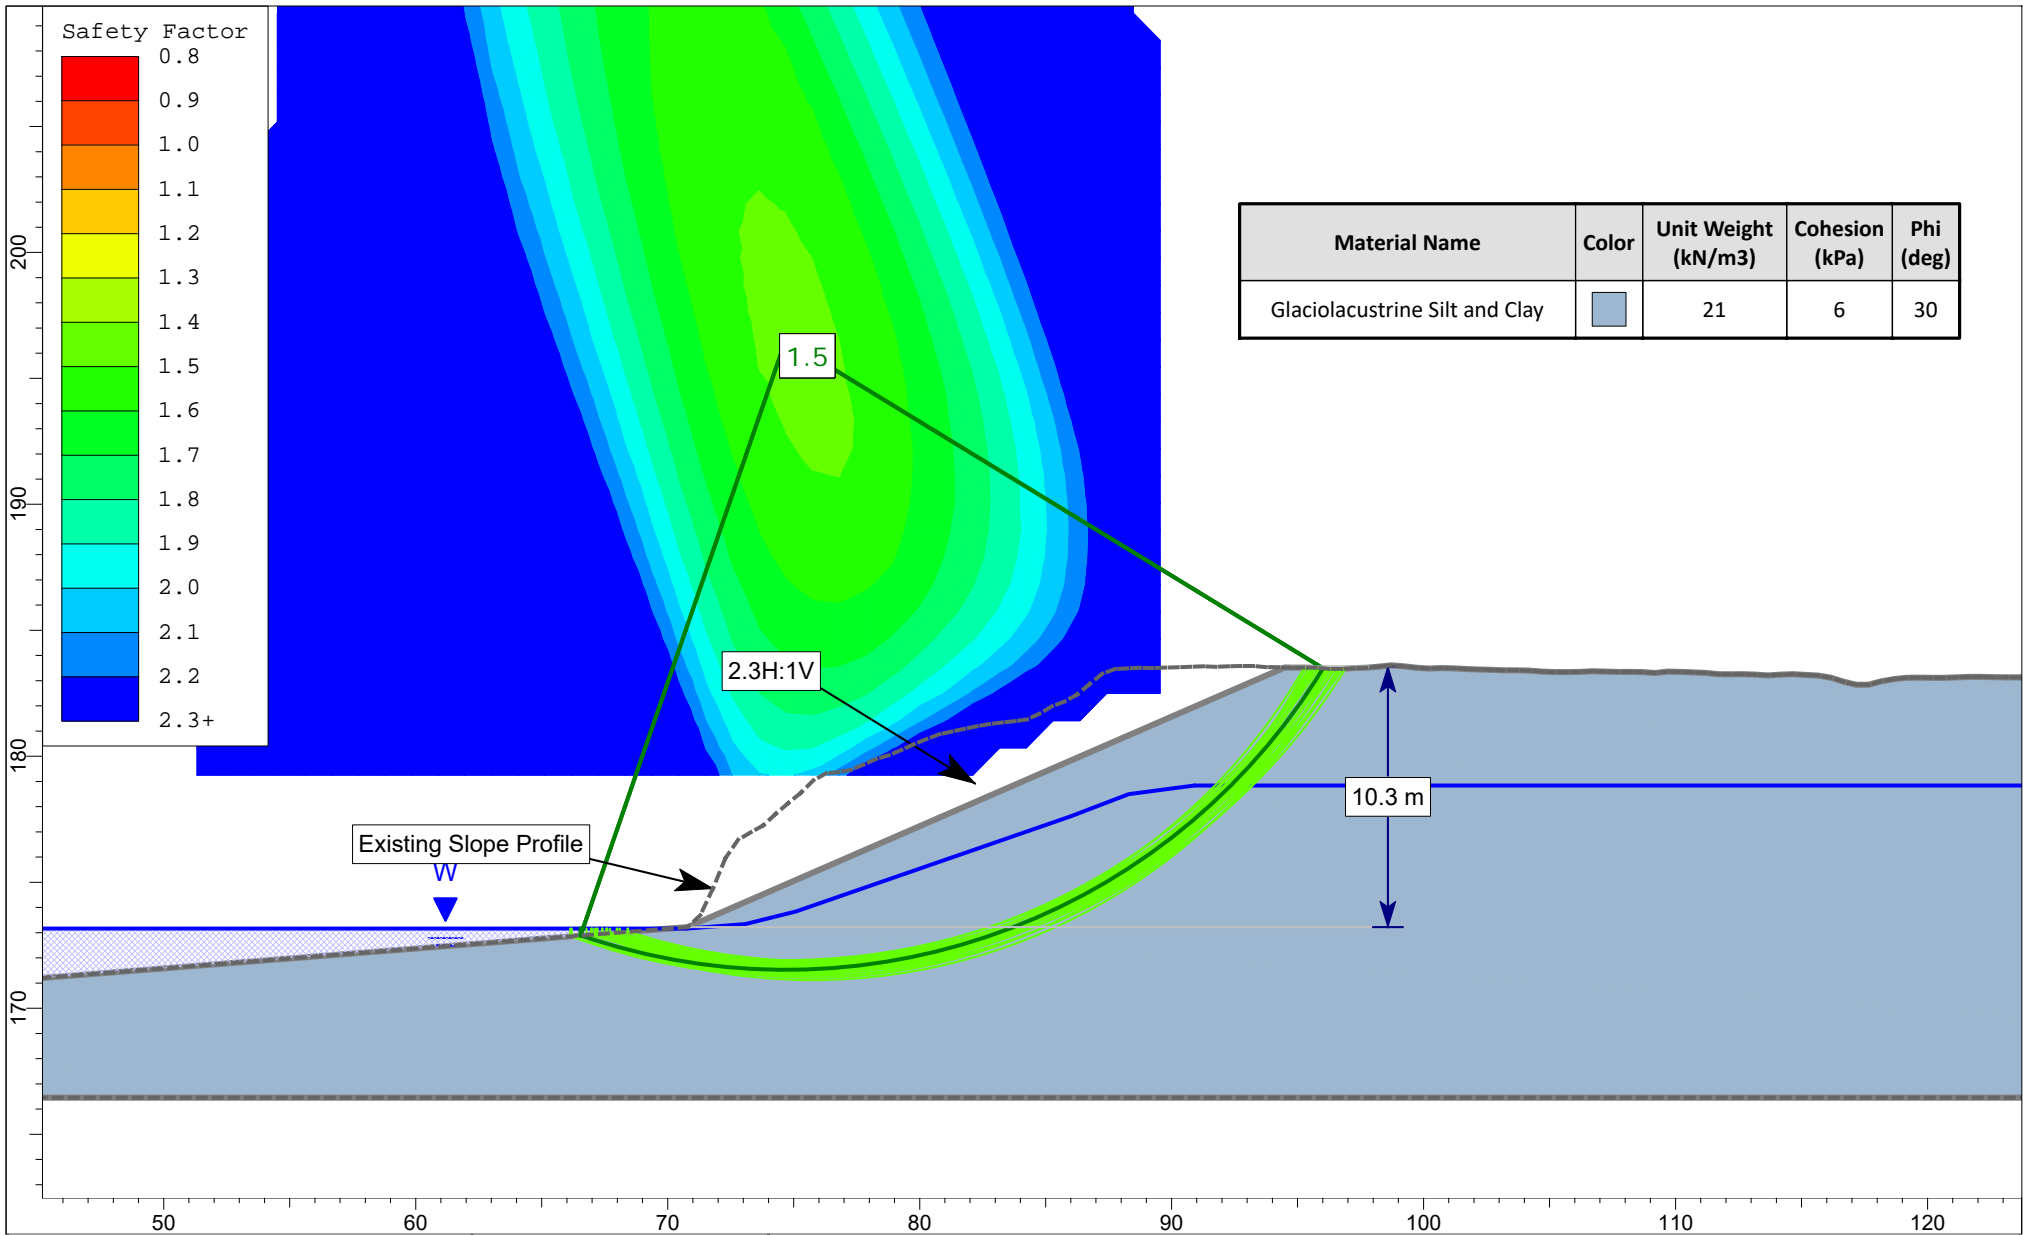
Project <b>Halimand County Slope Stability   1-18-0402-01</b>		
Analysis Global Stability: Section 8 SSI, Master Scenario		
Date 5/14/2019	Scale 1:300	File Halimand Part 2 v2.slm
By JH/JC	Ref. 2017 LiDAR data, provided by Baird on March 13, 2019

→ At section B, tension cracks in the upper slope face.

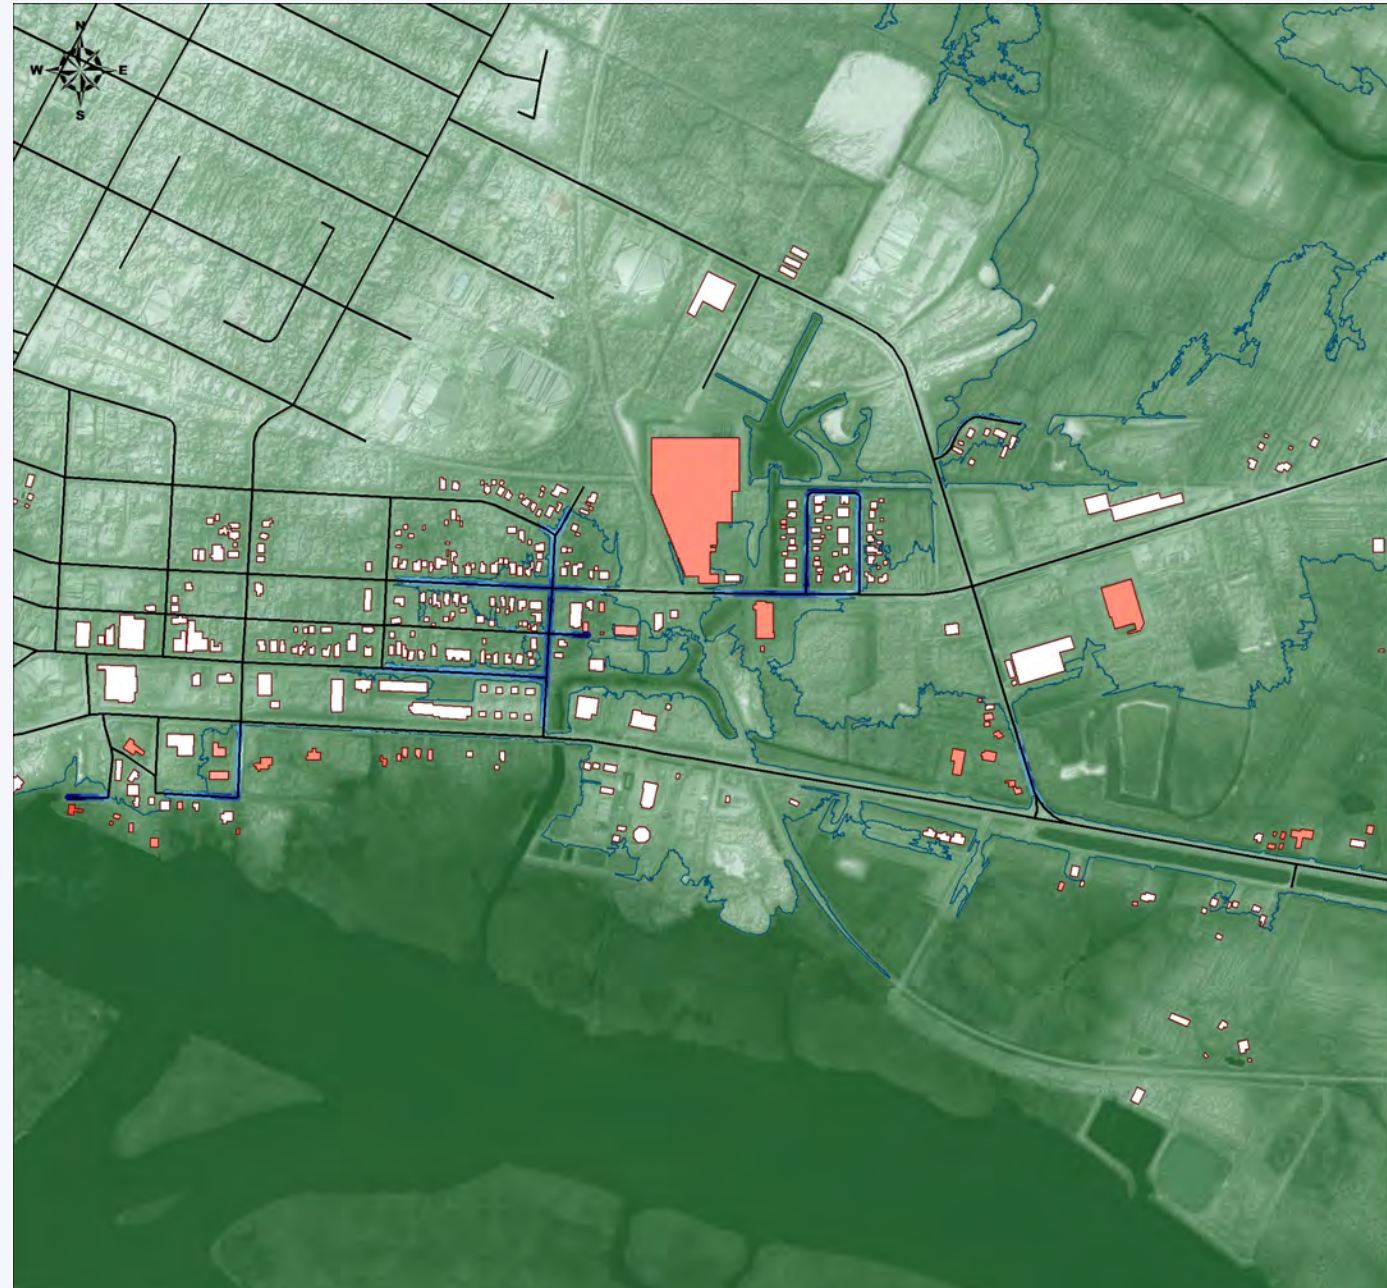
**Dunnville 100 Year**

100-yr flood level = 176.2m  
CGVD2013

Street	Flood level when street becomes impacted	
	CGVD2013	IGLD85
HYDRO STREET	175.2	175.7
TAMARAC STREET & FRONT STREET	175.8	176.2
BROAD STREET EAST	175.7	176.1
NIAGARA STREET	175.6	176.1
CENTRAL LANE	175.3	175.8
QUEEN STREET	175.8	176.3
BRANT STREET & BRACE STREET	175.6	176.1
TAYLOR ROAD	176.0	176.5

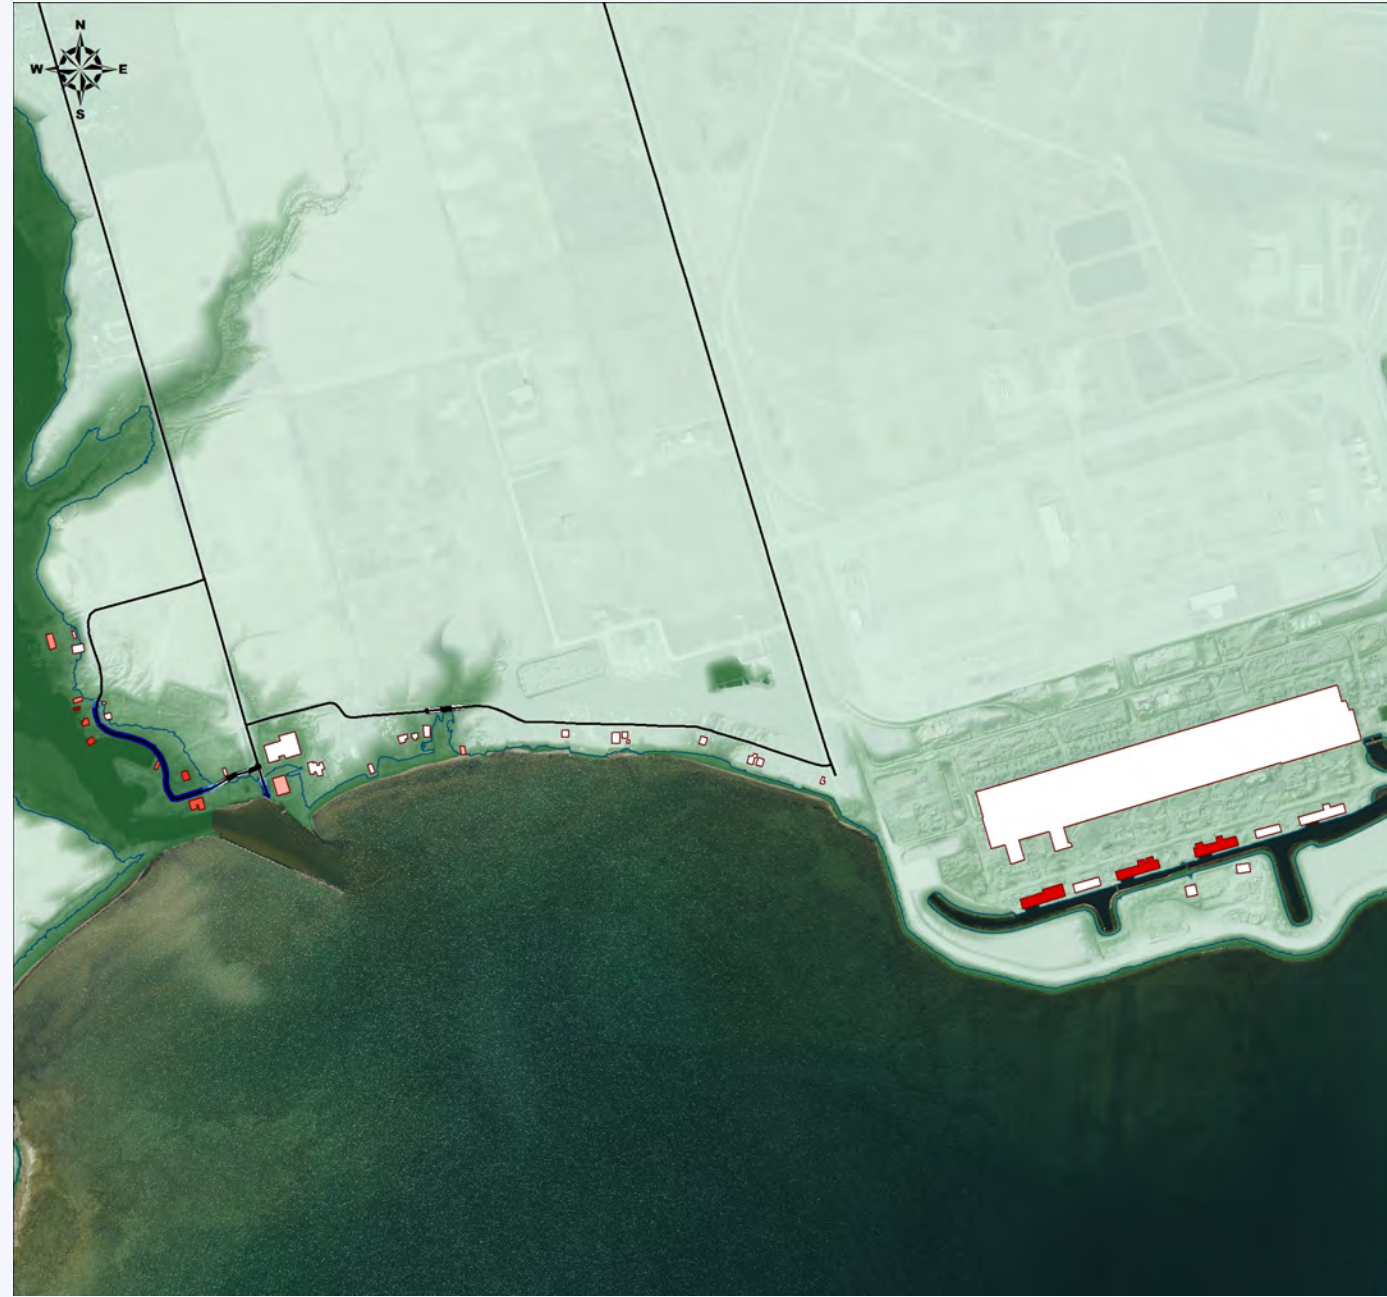
**Nanticoke (R7)  
100 Year**

100-yr flood level = 175.9m  
CGVD2013

Street	Flood level when street becomes impacted	
	CGVD2013	IGLD85
ERIE AVENUE	174.9	175.4
ERIE STREET	174.9	175.4

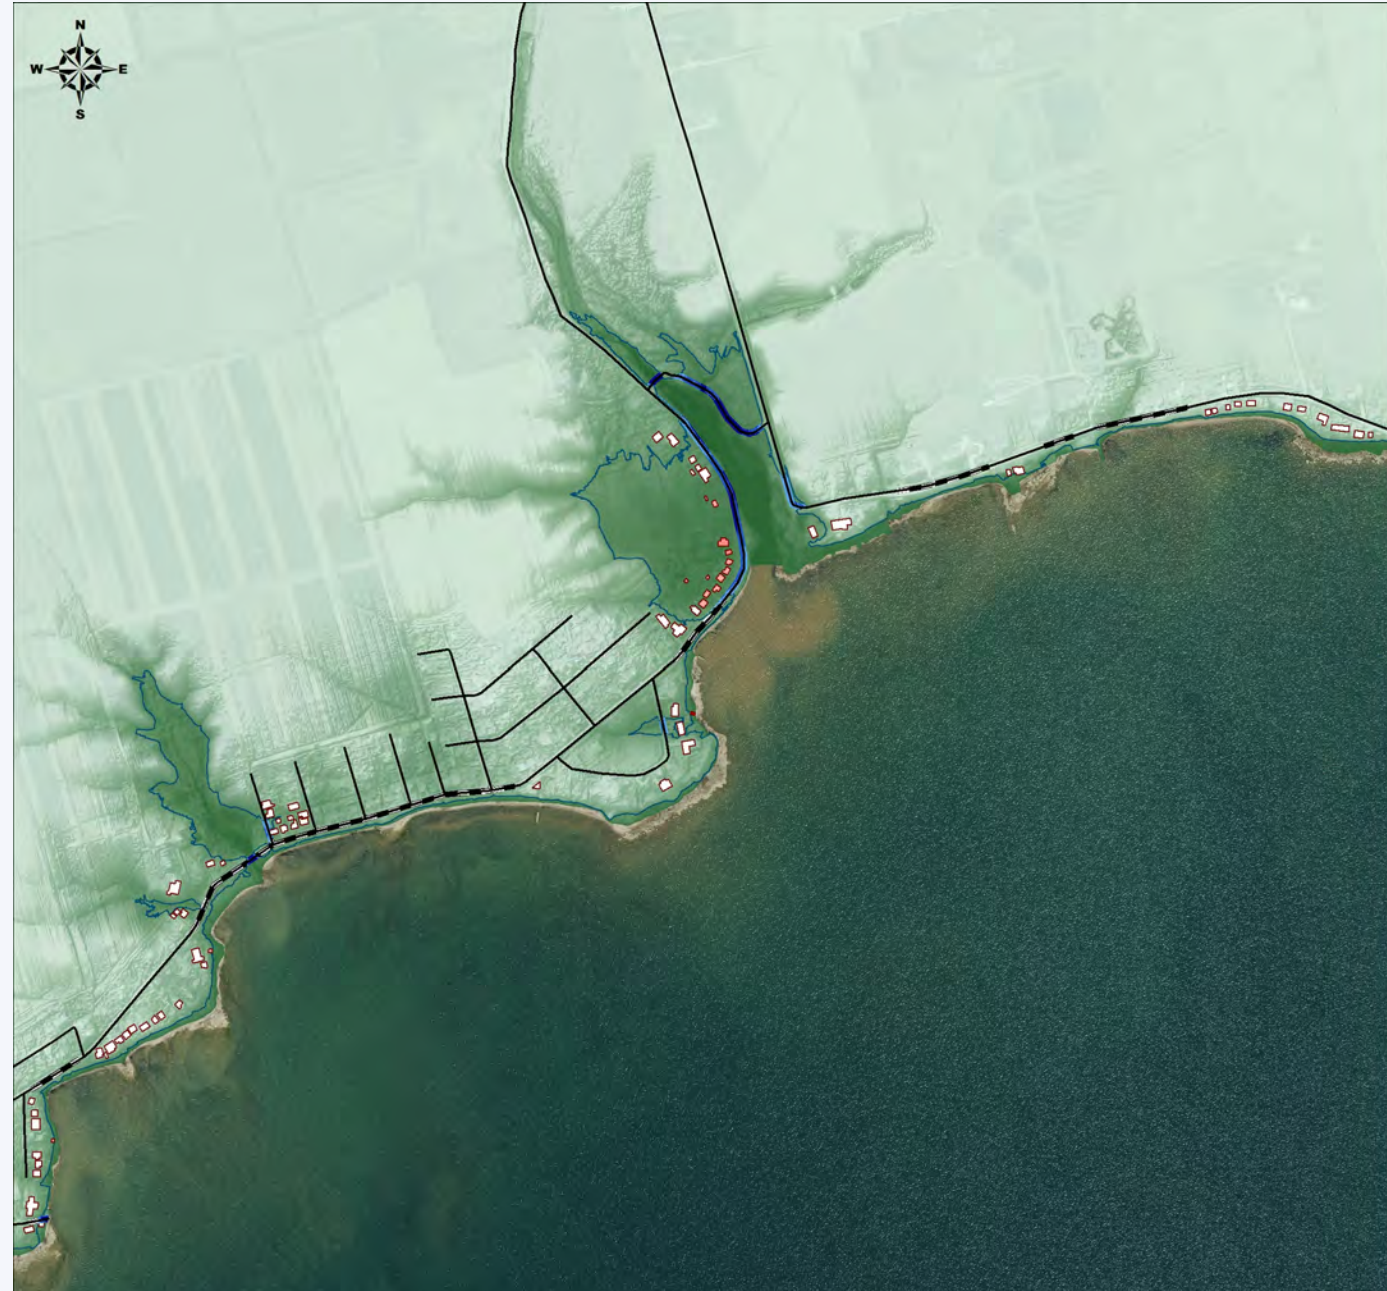
**Selkirk (R22)**  
100 Year

100-yr flood level = 176.0m  
CGVD2013

Street	Flood level when street becomes impacted	
	CGVD2013	IGLD85
BLUE WATER PKWY	175.3	175.8
EAST LAKESHORE RD	174.1	174.6
HALDIMAND ROAD 53	175.7	176.2

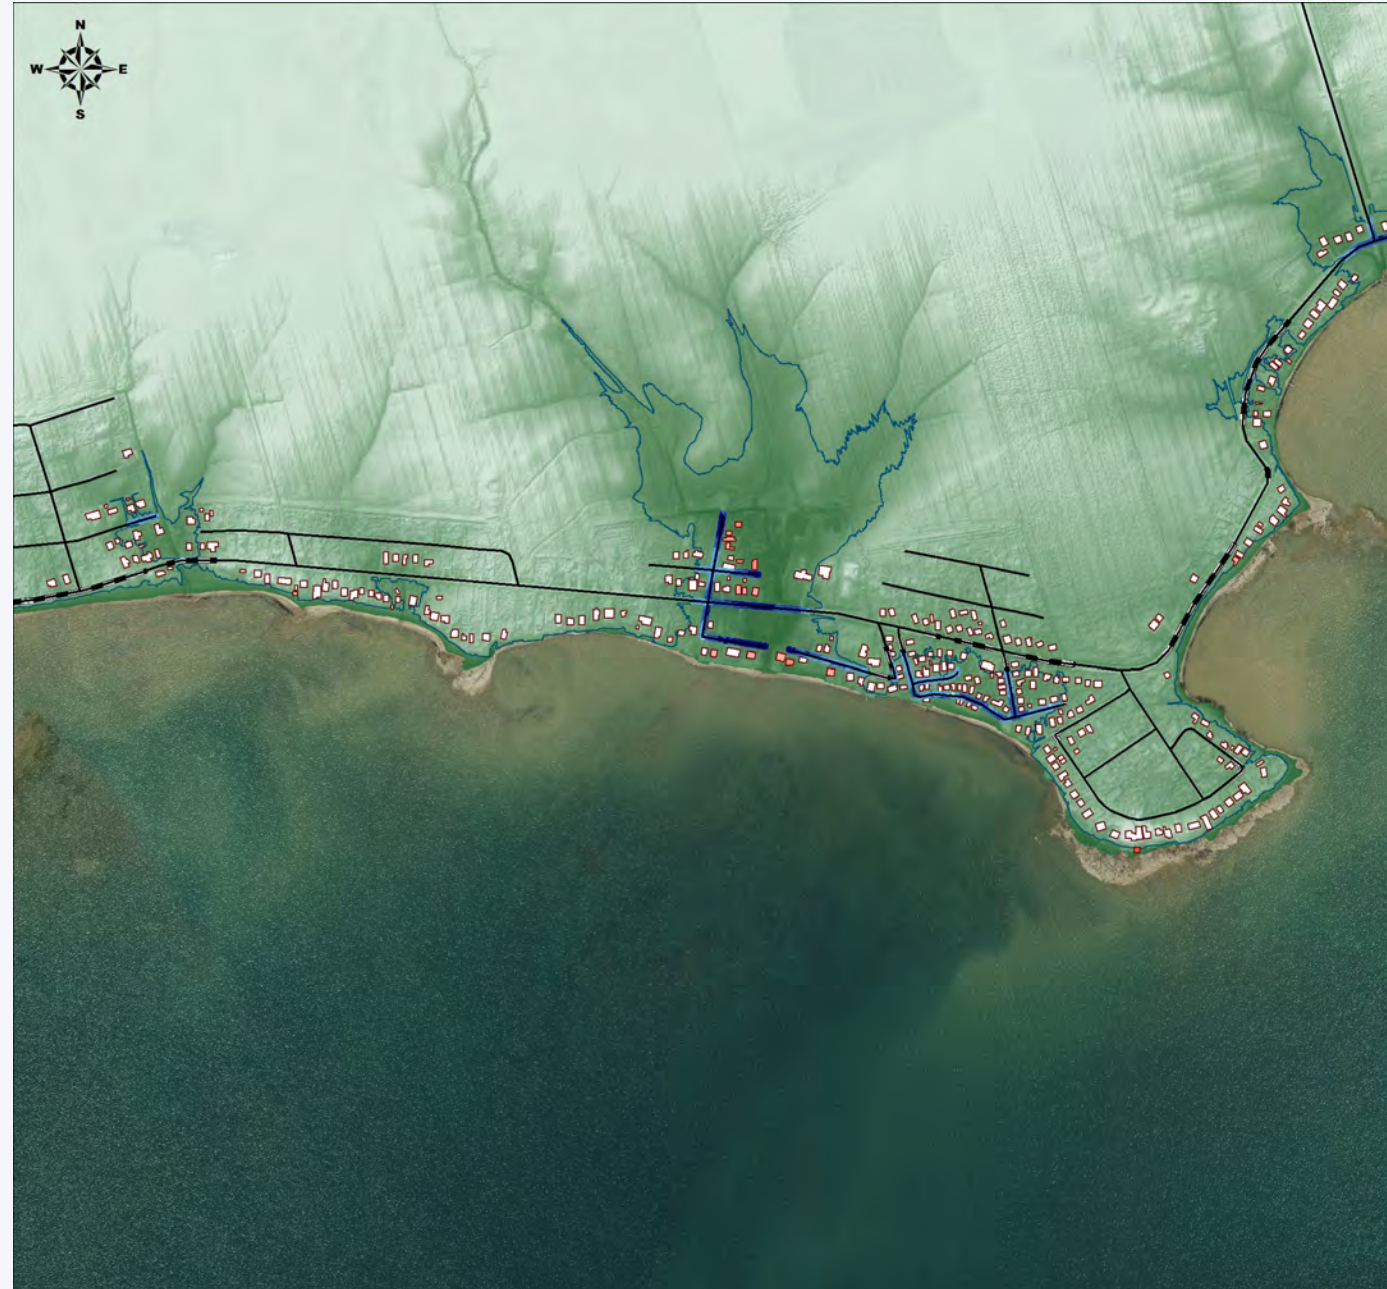
**Featherstone Point (R38) 100 Year**

100-yr flood level = 176.1m  
CGVD2013

Street	Flood level when street becomes impacted	
	CGVD2013	IGLD85
BIRCH LANE	175.4	175.9
SWALLOW LANE	175.3	175.8
LAKESHORE ROAD	175.5	175.9
SEAGULL LANE	174.6	175.1
WINGER BAY LANE	175.4	175.8
AULD LANE	176.0	176.4
VIDEOWAY LANE	175.8	176.3
HEATHER LANE	175.5	176.0
PIKE LANE	175.8	176.2
LAKESHORE ROAD (at KOHLER ROAD)	175.6	176.0
