# Haldimand County Lake Erie Hazard Mapping and Risk Assessment

Technical Report

March 19, 2020 | 12969.101.R2.Rev3

W.F. Baird & Associates Coastal Engineers Ltd.  
and  
Terraprobe Inc.

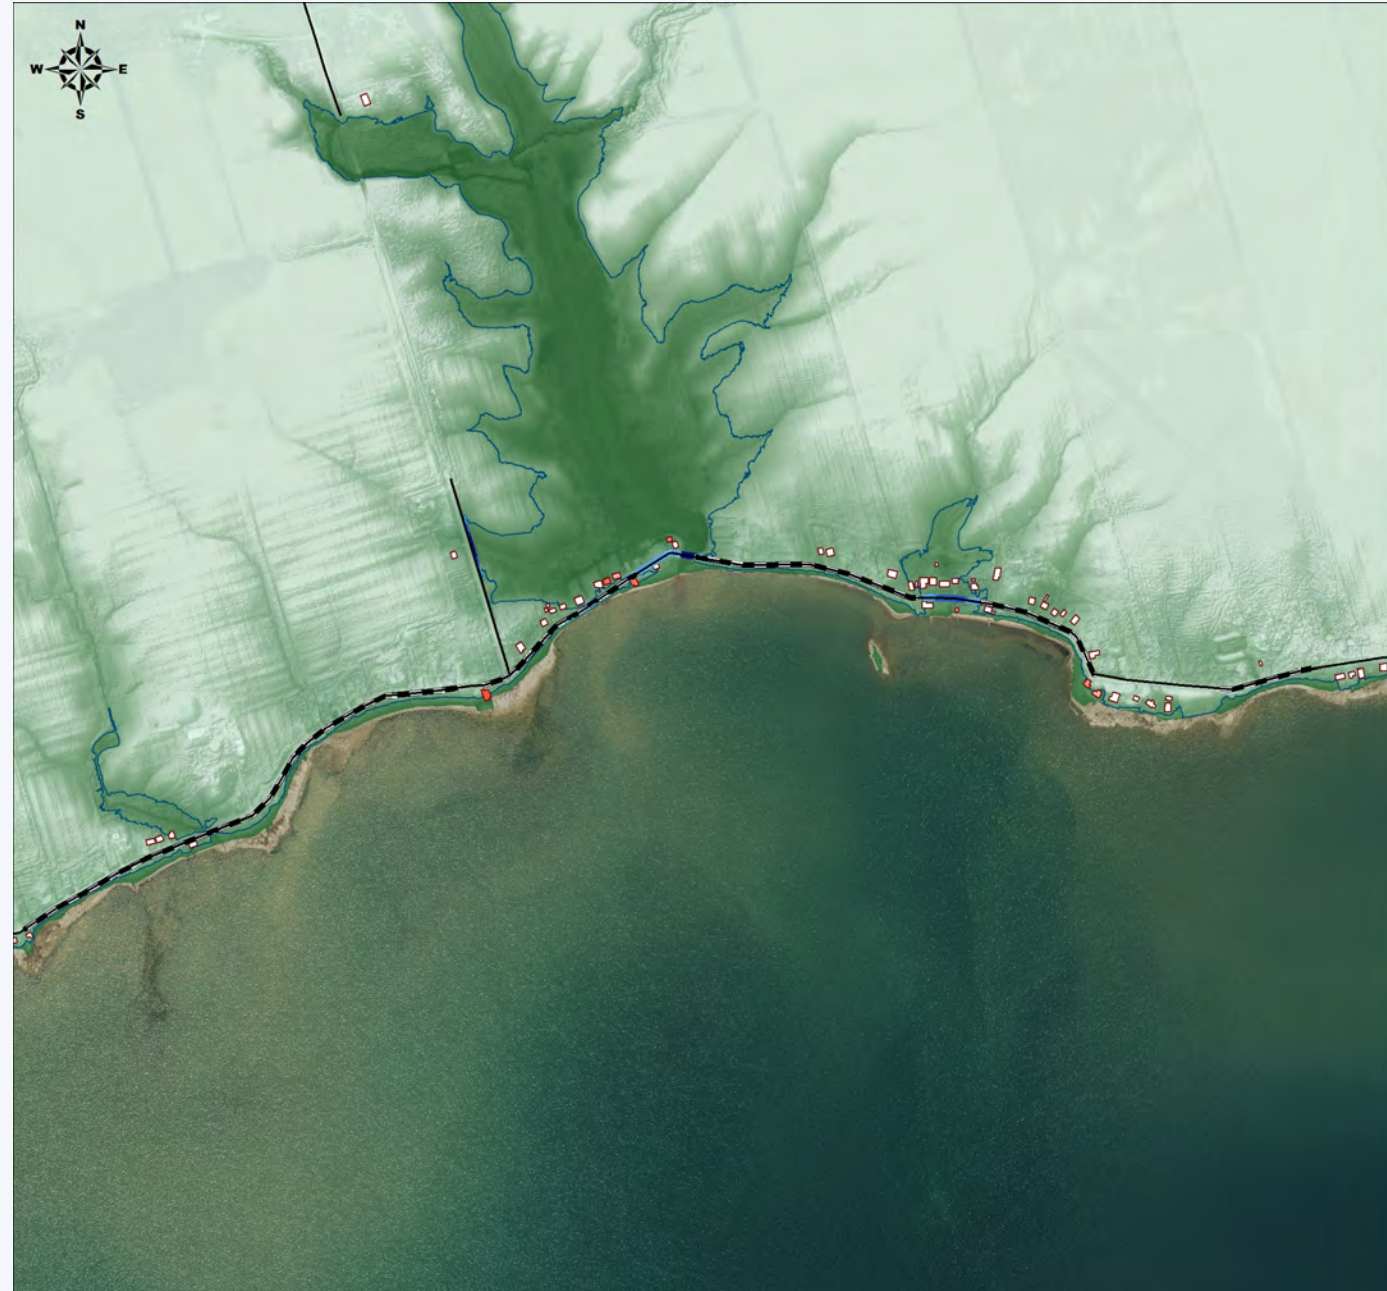
**Featherstone Point (R42) 100 Year**

100-yr flood level = 176.1m  
CGVD2013

Street	Flood level when street becomes impacted	
	CGVD2013	IGLD85
REICHEL ROAD	175.1	175.6
LAKESHORE ROAD	175.7	176.2

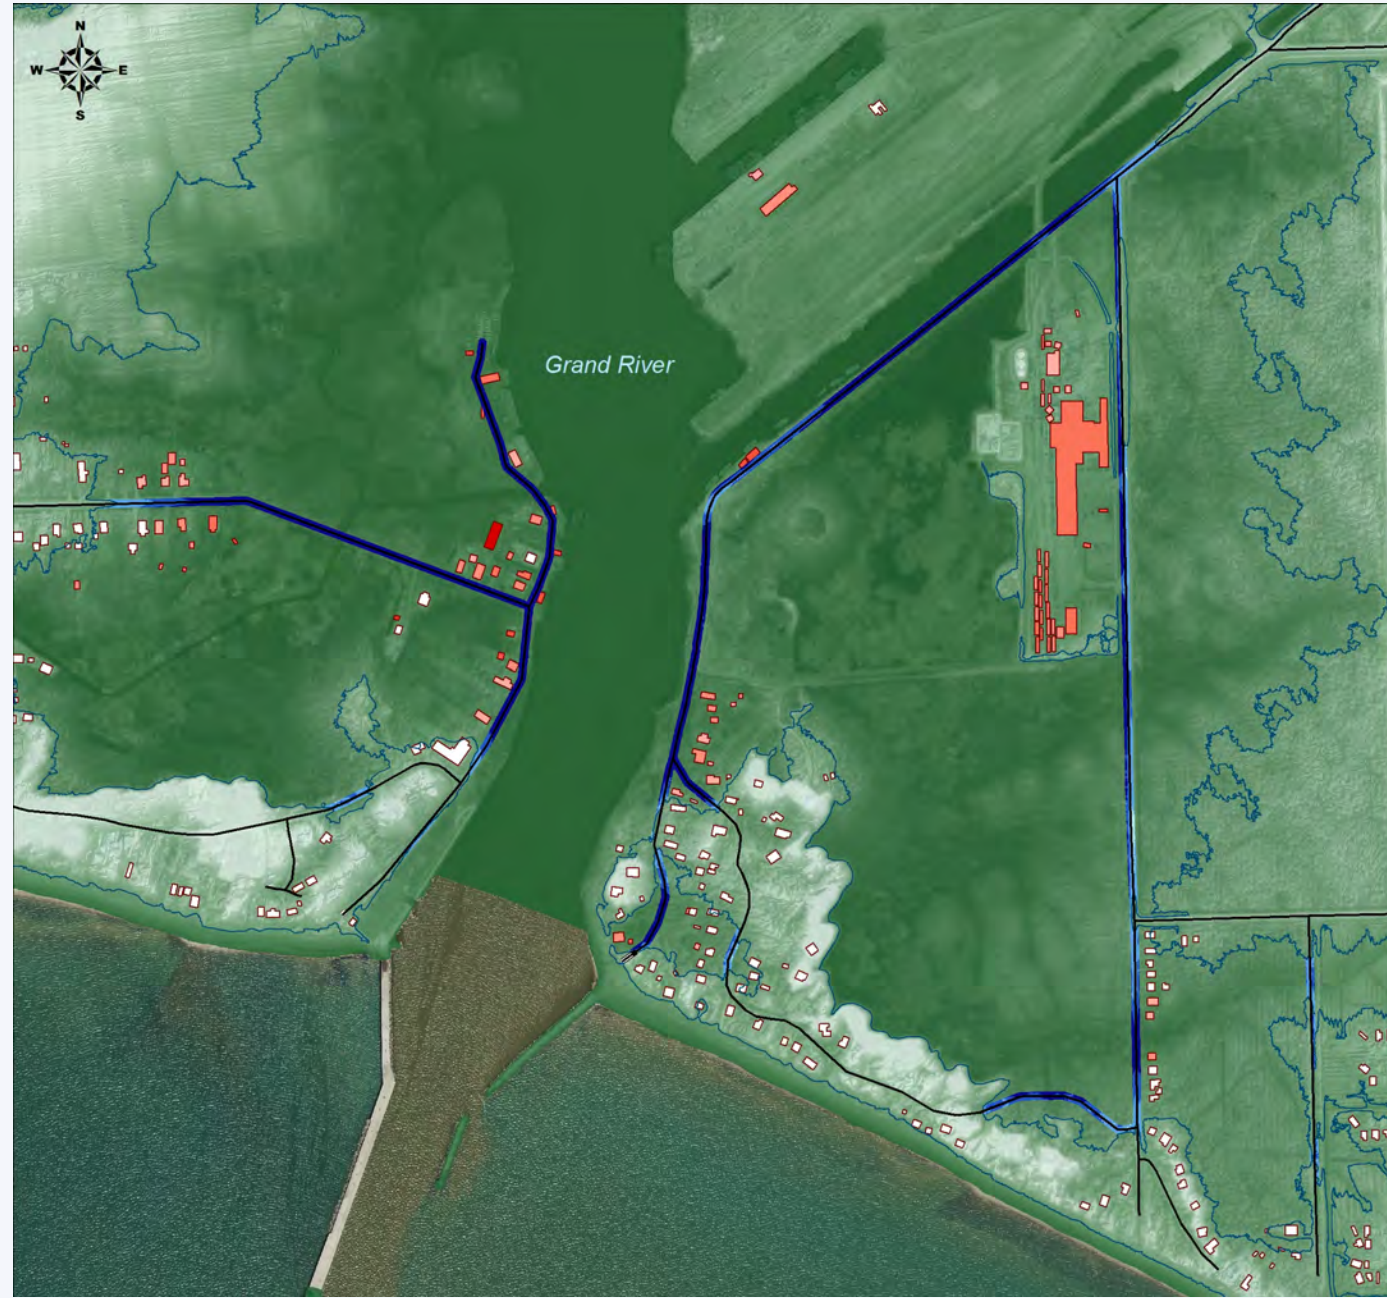
**Port Maitland 100 Year**

100-yr flood level = 176.2m  
CGVD2013

Street	Flood level when street becomes impacted	
	CGVD2013	IGLD85
DOVER STREET	175.8	176.3
PORT MAITLAND RD	174.9	175.4
THE ESPLANADE	174.6	175.0
FEEDER CANAL RD	175.0	175.4
SIDDALL ROAD	175.5	176.0
BECKLY LINE	175.0	175.5
SIDDALL LINE	175.3	175.8
CONNOR BAY LINE	175.8	176.3
